The 1991

Survey

of the

California Department of Forestry and Fire Protection's

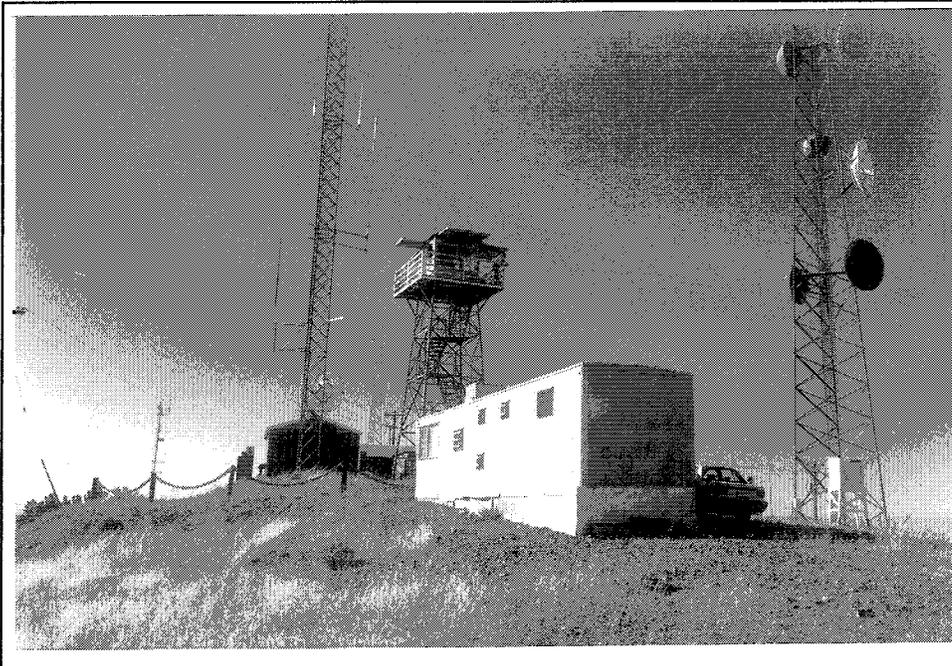
7. Briefly describe the present physical appearance of the property, including condition, boundaries, related features, surroundings, and (if appropriate) architectural style. This fire lookout station consists of an 11'6"x11'6" (base) x29' (high) battered, open steel (X-brace) tower and a 296 sq. ft. trailer-residence. The tower has a concrete pier foundation and is topped with a 49 sq. ft. metal observation cab. A stairway extends up inside the tower to a wooden trap door in the cab floor. Cab windows are 1/1 sliders. A wood door (with glass upper panel) opens onto the 36" wide catwalk (42" high guardrail). The cab has a metal, pyramidal hip roof. The residence is a wood frame, aluminum sided trailer, consisting of a bedroom, kitchen and bathroom. A 12'x20' garage is located near the tower. The rectangular wood frame building has a concrete slab foundation, redwood "v" groove rustic lap siding and asphalt composition roofing over a gable roof. Garage doors swing open on the east side to provide vehicle access. Commercial power and telephone are on site.

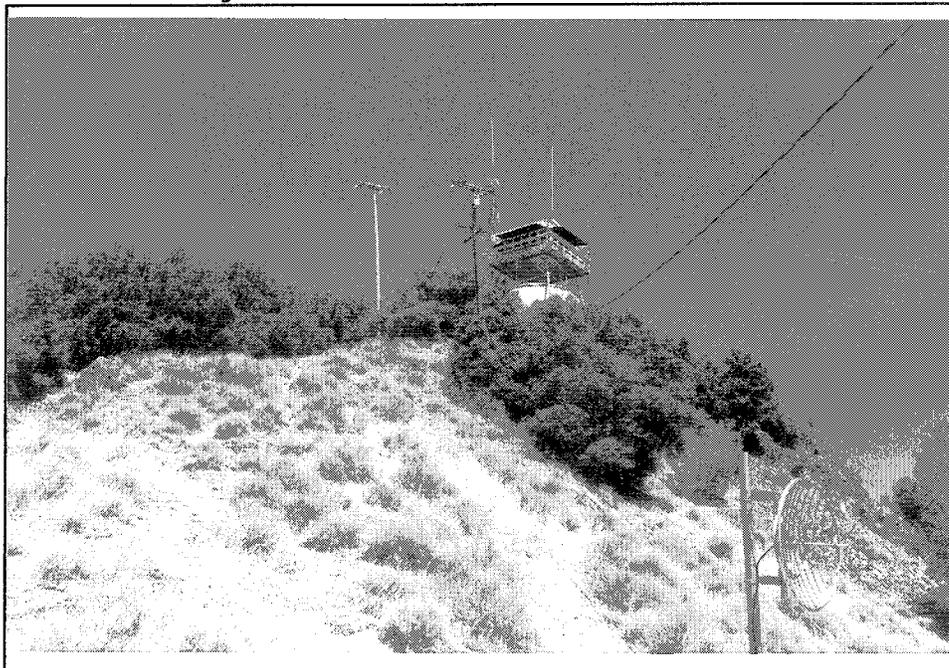
7. Briefly describe the present physical appearance of the property, including condition, boundaries, related features, surroundings, and (if appropriate) architectural style. This 13'6"x13'6" (base) x13' (high) battered, open steel (K-brace) tower has a concrete pier foundation which straddles a 10,000 gallon concrete water storage tank. The tower supports a 196 sq. ft. wood frame cab. A stairway on the north side of the tower extends up to the catwalk. The metal-wood catwalk and handrail are 33" wide by 42" high (respectively). The square cab features hopper windows centered between two stationary panes on three sides, with a wood door (that has a glass upper panel) centered on the fourth (east) wall. Aluminum sheeting covers the pyramidal hip roof. The cab has T&G flooring and ceiling, and built-in cabinets. The associated 240 sq. ft. garage is a rectangular frame building with a concrete slab foundation, "v" groove siding and asphalt composition covered gable roof. Garage doors swing open, providing access on the east side. A single window is centered on both the north and south walls.

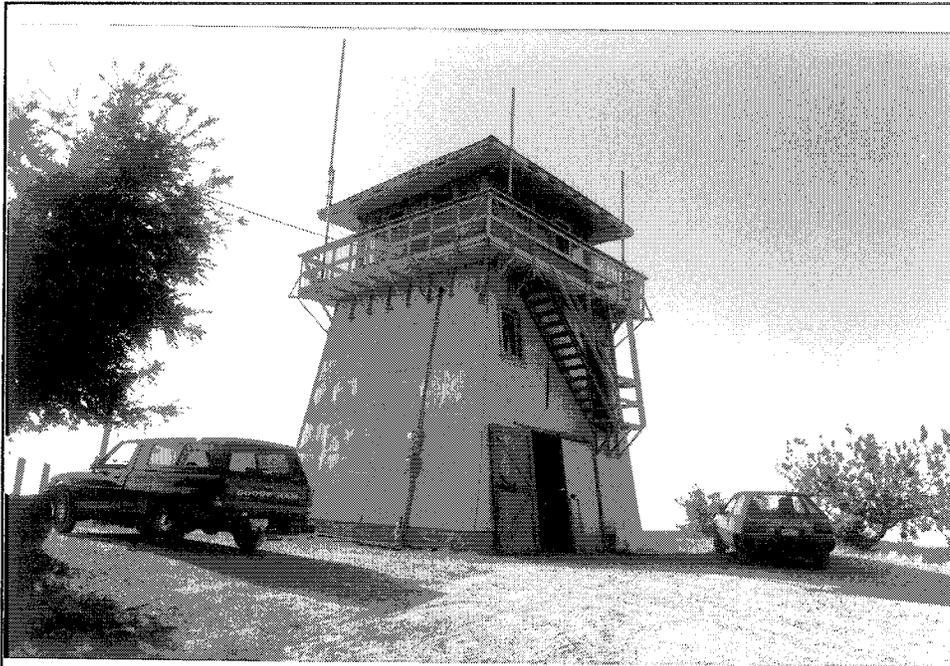
7. Briefly describe the present physical appearance of the property, including condition, boundaries, related features, surroundings, and (if appropriate) architectural style. This 20'x20' (base) x18' (tall) battered enclosed timber tower has a concrete perimeter foundation, concrete flooring, aluminum siding and is topped by a 196 sq. ft., wood frame cab with pyramidal hip roof. Roofing is asphalt composition; eaves were boxed, the fascia is missing. Two large doors, which swing open to provide ground floor access, are centered on the east wall of the tower. An internal stairway leads to the second floor which serves as a bathroom/study area. The second story has T&G flooring but is otherwise unfinished. External, steel stairs lead from the second floor to the catwalk. Hopper windows are centered between two fixed windows on three sides of the cab. A wood door (with glass upper panel) is off-set on the east wall. The cab has vinyl tile flooring, raised T&G ceiling and built-in cabinets. Louvre vents are centered in the wall space above the cab windows.

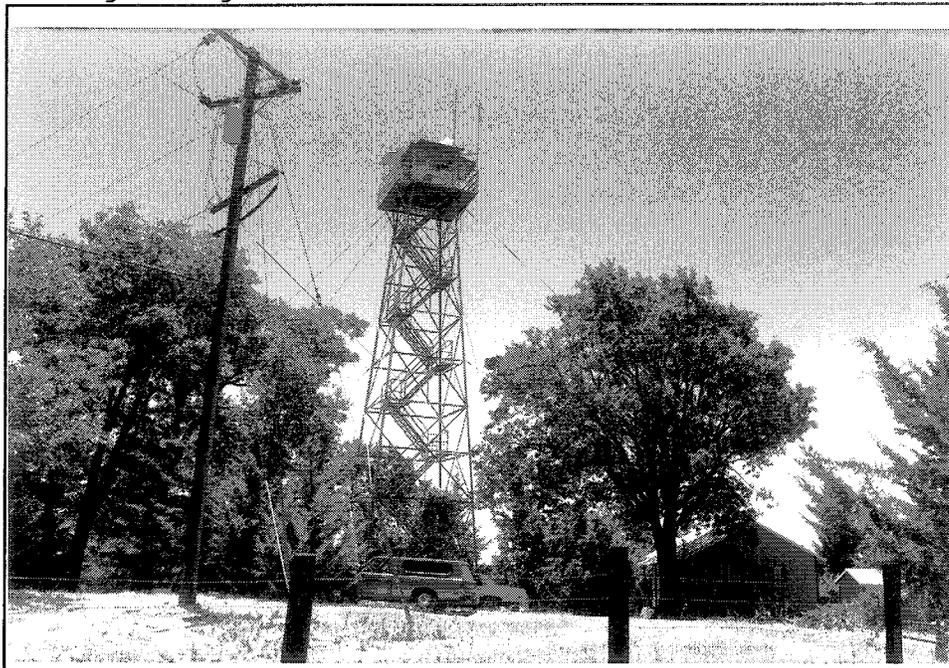
7. Briefly describe the present physical appearance of the property, including condition, boundaries, related features, surroundings, and (if appropriate) architectural style. This station consists of an Aermotor tower, a single story wood frame residence, and a small wood frame pump house. The battered, open steel (X-brace) tower measures 16'x16' (base) x60' (high) and has a concrete pier foundation. A stairway extends up inside the tower to a wooden trap door in the floor of the 49 square foot cab. The cab's casement, metal frame windows are centered between stationary glass. A metal door (with glass upper panel) opens onto the 32" wide catwalk (42" high railing). The cab has a metal, pyramidal hip roof. The 420 square foot, rectangular residence has a concrete perimeter foundation, vertical groove plywood siding and asphalt composition roofing on a gable roof. Aluminum sliding windows are featured throughout. A small concrete porch with shed roof protects the front entry of the house. The pump house has a concrete slab foundation, plywood siding and gable roof.

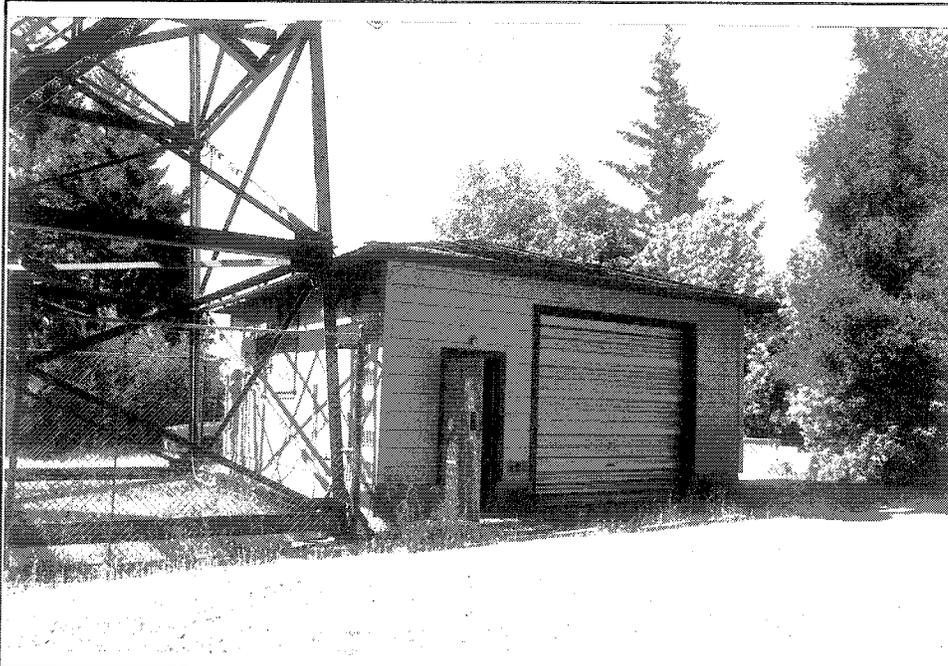
7. Briefly describe the present physical appearance of the property, including condition, boundaries, related features, surroundings, and (if appropriate) architectural style. This station consists of a battered, open steel (X-brace) tower measuring 22'7"x22'7" (base) x51'6" (high) and a square, single story wood frame utility building. The tower has a concrete pier foundation. Stairs extend up inside the tower to a wooden trap door in the floor of the 225 sq. ft. metal frame cab. Casement windows are centered between two fixed windows on three sides of the cab. A glass pane over panel metal door, centered between two windows, is located on the southeast cab wall. The steel/wood catwalk and guardrail are 24"x43" (respectively). Asphalt composition shingles cover the pyramidal hip roof. Eaves feature a plain fascia. The cab has aluminum siding, T&G flooring and built-in cabinets. The 484 sq. ft. utility building has a concrete slab foundation, "v" groove siding, asphalt composition shingles over a pyramidal hip roof and plain fascia.

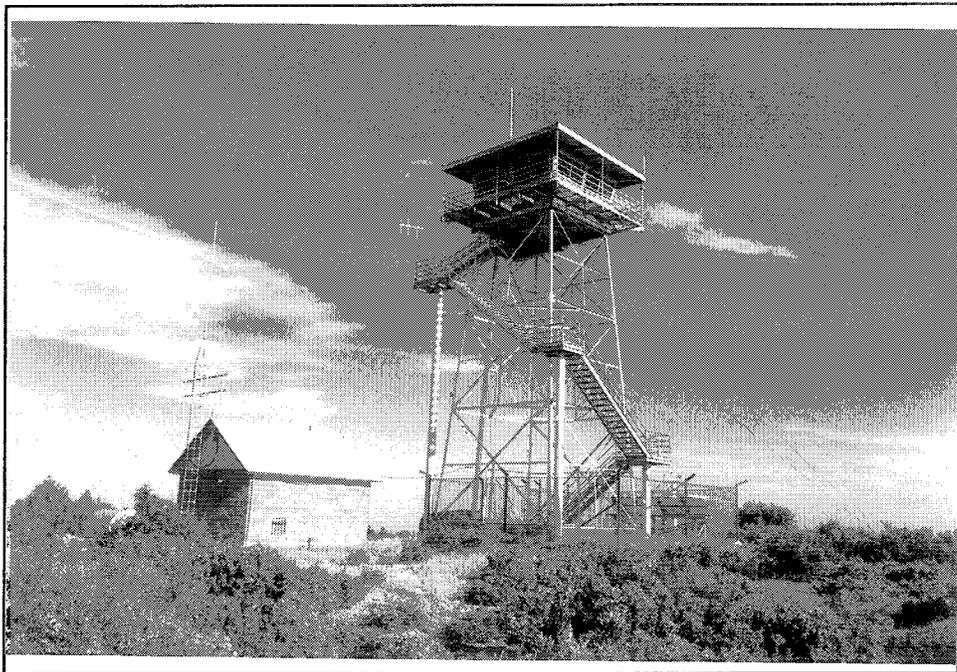
7. Briefly describe the present physical appearance of the property, including condition, boundaries, related features, surroundings, and (if appropriate) architectural style. This station consists of a battered, open steel (X-brace) tower measuring 19'6"x19'6" (base) x45'6" (high) and a single story, concrete block utility building. The tower has a concrete pier foundation and supports a 196 sq. ft. aluminum sided, wood frame cab. A self supporting, steel stairway wraps around the outside of the tower. The cab has vinyl tile flooring, open beam ceiling and built-in cabinets. The cab's pyramidal hip roof is covered with asphalt composition shingles. Eaves feature aluminum covered fascia boards. Cab windows are tilted, aluminum sliders. The door is off-set on the south side. The steel catwalk and guardrail are 36" by 42". The 272 sq. ft. utility building is divided into a bathroom/water storage and a radio/generator storage area. The gable roof structure has a concrete slab foundation and asphalt composition roofing.

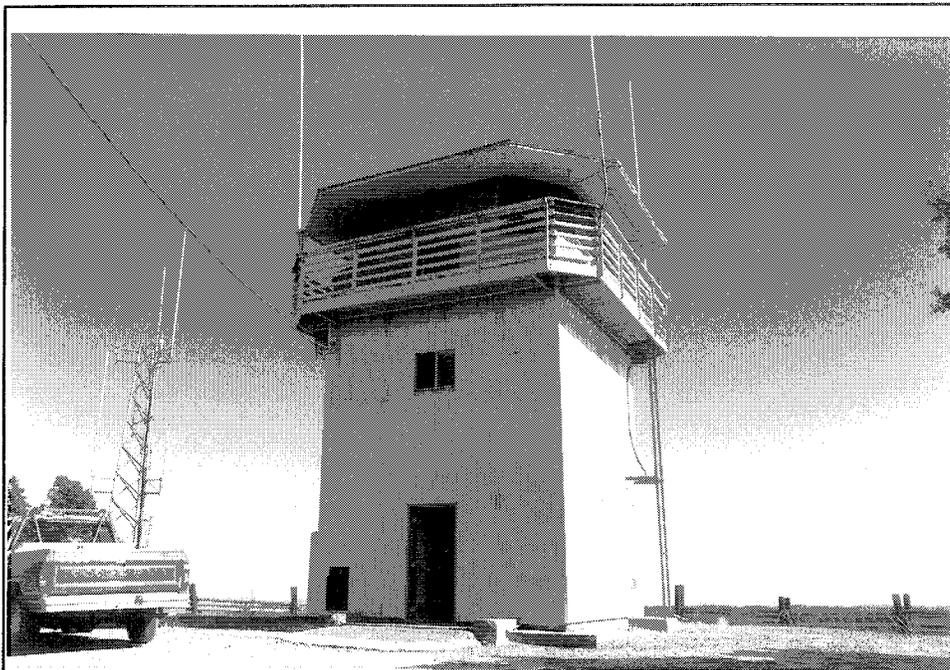
7. Briefly describe the present physical appearance of the property, including condition, boundaries, related features, surroundings, and (if appropriate) architectural style. This 16'x16'x20' (tall) enclosed steel (K-brace) tower has a concrete slab foundation, corrugated metal siding over wood framing and supports a 247 square foot wood frame cab with octagonal roof and window patterning. Roofing is asphalt composition; eaves are boxed. Ground floor access is via a hollow, metal entry door centered on the tower's north wall. A water pumping system is on the ground floor. The second floor is finished off and contains a bedroom and bathroom. There are single 1/1 windows centered on the north and east walls of this floor. The cab has linoleum flooring, "v" groove (T&G) paneling and vaulted, T&G ceiling. Cab windows are stationary plate glass (hopper type on the diagonals for ventilation). The cab door is centered on the east side. The wood catwalk is 32" wide and the handrail is 42" high.

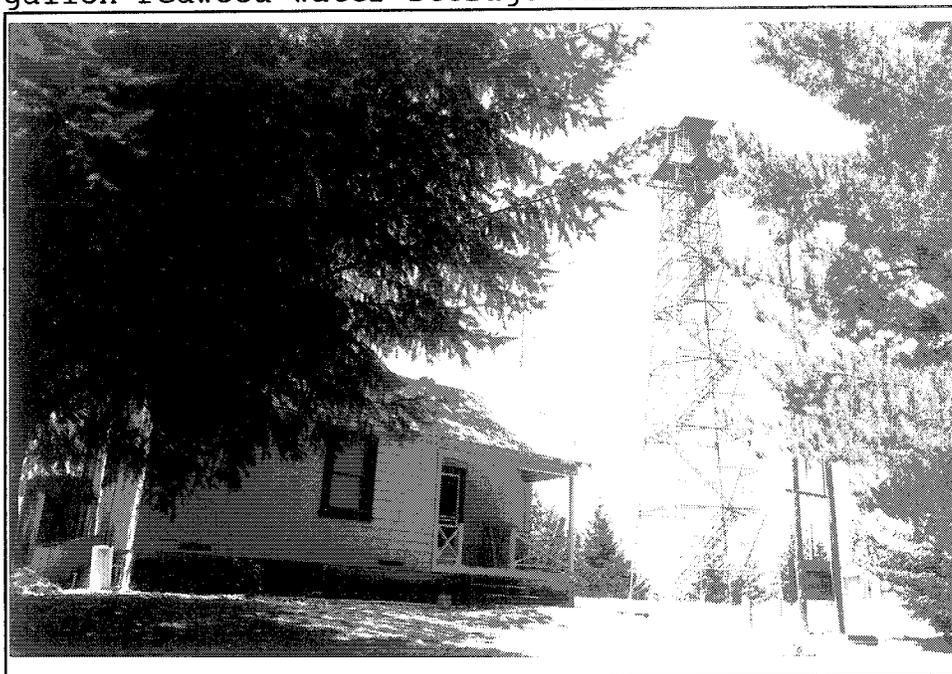
7. Briefly describe the present physical appearance of the property, including condition, boundaries, related features, surroundings, and (if appropriate) architectural style. This station consists of an Aermotor tower, a single story wood frame residence, and a battered, enclosed timber (water) tower. The battered, open steel (X-brace) tower measures 19'6"x19'6" (base) x83' (high) and has a concrete pier foundation. Stairs extend up inside the tower to a wooden trap door in the floor of the 49 square foot cab. Cab windows are 1/1 sliders and a metal door (with glass upper panel) opens onto the 36" wide catwalk with 42" high handrail. The cab has a metal, pyramidal hip roof. The 540 square foot, rectangular residence has a concrete perimeter foundation, "v" groove lap siding and wood shingles on a gable roof. A 6'x12' entry porch is recessed under the main roof on the northwest side of this structure. The 10'x10' (base) x17' (high) water tower has a concrete slab foundation, "v" groove lap siding and is topped with a 5,000 gallon redwood water storage tank.

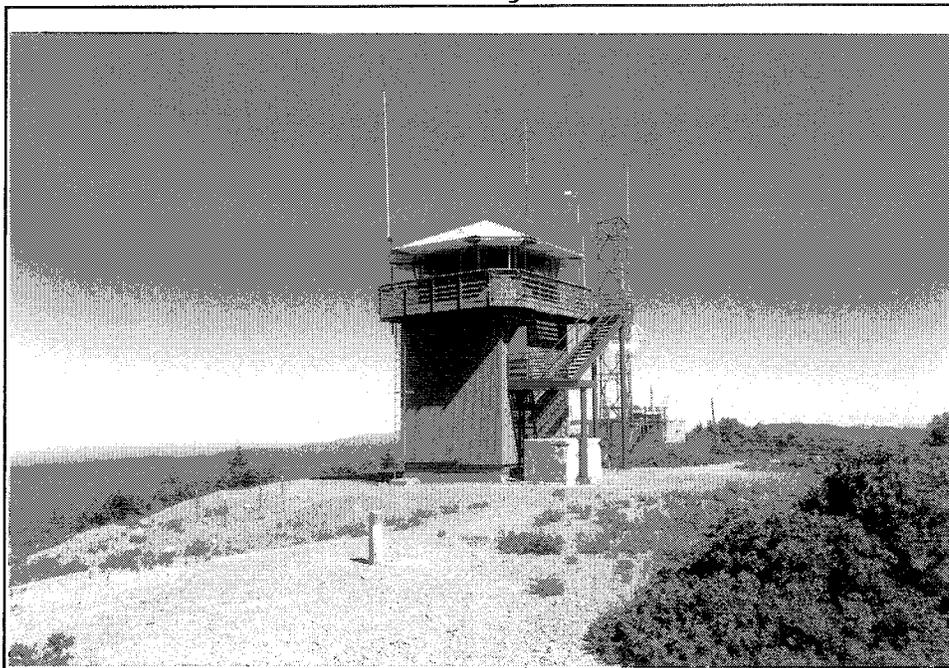
7. Briefly describe the present physical appearance of the property, including condition, boundaries, related features, surroundings, and (if appropriate) architectural style. This 16'x16' (base) x20' (tall) battered, enclosed timber tower has a concrete perimeter foundation, concrete flooring, corrugated metal siding over wood framing and is topped by a 247 square foot wood frame cab with octagonal roof and window patterning. Roofing is asphalt composition; eaves are boxed. The tower entry is via a metal door (which has a glass upper panel) located off-set on the north wall. Bathroom, water and radio facilities are located on the ground floor. An internal stairway leads to the second floor bedroom area, which has T&G flooring and exposed framing with plywood paneling. An external stairway leads from the second floor up to the catwalk. The cab has vinyl tile flooring, vaulted ceiling, built-in cabinets and electric appliances. The windows are tilted, stationary plate glass. The door is centered on the east side. The wood catwalk is 36" wide and the handrail is 42" high.

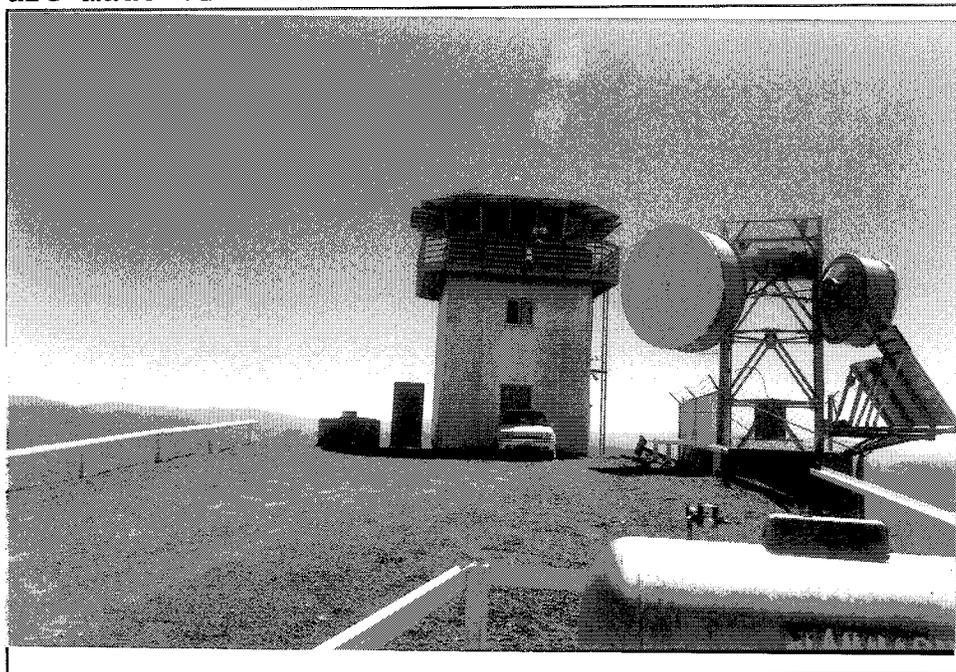
7. Briefly describe the present physical appearance of the property, including condition, boundaries, related features, surroundings, and (if appropriate) architectural style. This 16'x16'x20' (tall) enclosed steel (K-brace) tower has a concrete slab foundation and corrugated metal siding over wood framing. The tower supports a 247 square foot wood frame cab with octagonal roof and window patterning. Roofing is asphalt composition; eaves are boxed. Ground floor access is via a hollow, metal entry door centered on the tower's west wall. A small water storage tank and repeater are on the ground floor. A bedroom and refrigerator are located on the second floor. The second story is partially finished with vertical, "v" groove (T&G) paneling. There are single 1/1 sliding windows centered on the west and south walls of this floor. The cab has linoleum flooring, vaulted ceiling, cabinets and propane appliances. Cab windows are tilted, stationary plate glass. The cab door is centered on the west side. The 32" wide catwalk and 42" high handrail are made of wood.

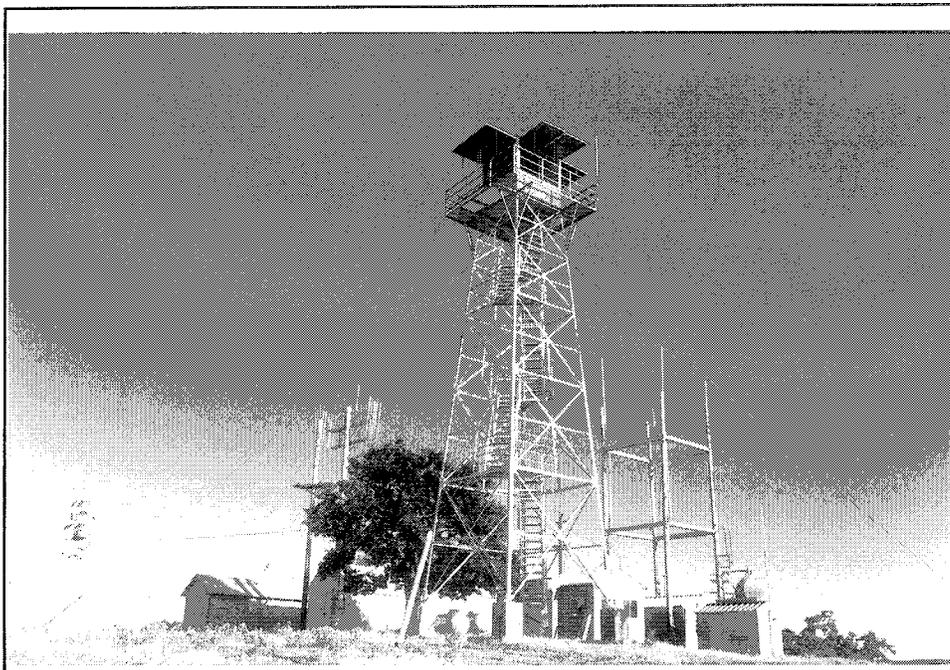
7. Briefly describe the present physical appearance of the property, including condition, boundaries, related features, surroundings, and (if appropriate) architectural style. The Pratt Fire Lookout Station consists of an Aermotor Company tower and a single story, wood frame residence. The battered, open steel (X-brace) tower measures 14'x14' (base) x45' (high) and has a 3'9" high concrete pier foundation. The tower supports a 49 sq. ft. metal observation cab. A stairway extends up inside the tower to a wooden trap door in the cab floor. Cab windows are 1/1 aluminum frame sliders. A metal door (with glass upper panel) opens unto the 36" wide catwalk. The handrail is 42" high. The cab has a metal, pyramidal hip roof. The 522 square foot residence is divided into two rooms (kitchen/office and bedroom) plus a small enclosed porch. The rectangular, gable roof structure has a concrete perimeter foundation, asbestos tile siding and asphalt composition roofing. The entry porch is located on the east gable end.

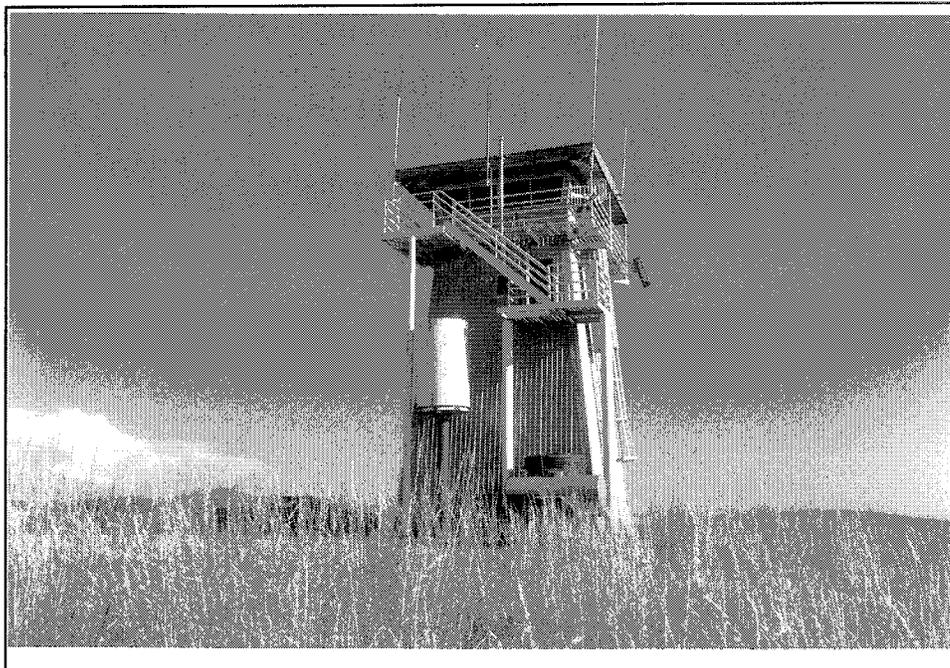
7. Briefly describe the present physical appearance of the property, including condition, boundaries, related features, surroundings, and (if appropriate) architectural style. This 20'x20' (base) x30' (tall) battered, enclosed timber tower has a concrete perimeter foundation, concrete flooring, corrugated metal siding over wood framing and is topped by a modern, 196 sq. ft. wood frame cab. Centered on the east side of the tower are heavy iron grate, gates which close over a metal entry door. A water storage tank and pressure system are on the ground floor. Bathroom facilities are located on the second floor. This room is 20 feet above the ground floor. External stairs lead from the second floor up to the catwalk. The square cab has vinyl tile flooring, open beam ceiling, built-in cabinets and propane stove. The cab's nearly flat gable roof is covered with corrugated metal. Eaves feature plain fascia. Cab windows are tilted, aluminum sliders. The door is off-set on the east side. The 34" catwalk, 46" handrail, are of steel construction.

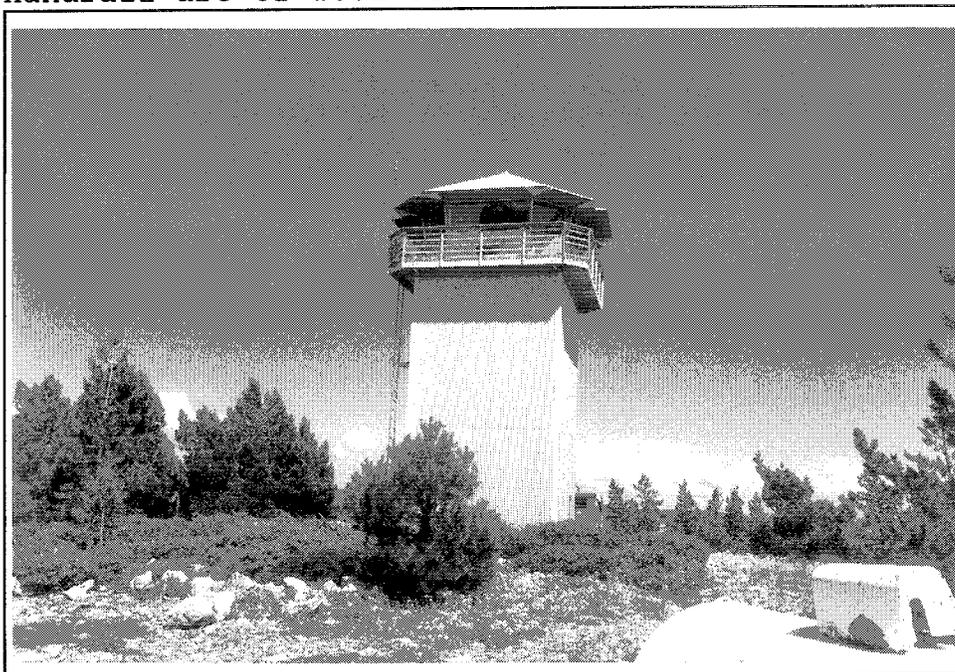
7. Briefly describe the present physical appearance of the property, including condition, boundaries, related features, surroundings, and (if appropriate) architectural style. This 16'x16'x29' (tall) enclosed steel (K-brace) tower has a concrete slab foundation, corrugated metal siding over wood framing (around the K-bracing) and is topped by a 247 sq. ft. wood frame cab with octagonal roof and window patterning. Roofing is asphalt composition; eaves are boxed. Ground entry is via a 3'x11'x7' (high) shed roof annex. A 1,000 gallon water storage tank and pressure system are on the ground floor. This and the second floor are unfinished, with framing and joists exposed. A single 1/1 double hung window is centered on the north and east walls of both the second and third floor of the tower. The third floor has plywood paneling. The cab has T&G flooring, plywood ceiling, built-in cabinets and propane stove. Cab windows are tilted, stationary plate glass. The door is centered on the east side. The 32" wide catwalk and 42" high handrail are of wood construction.

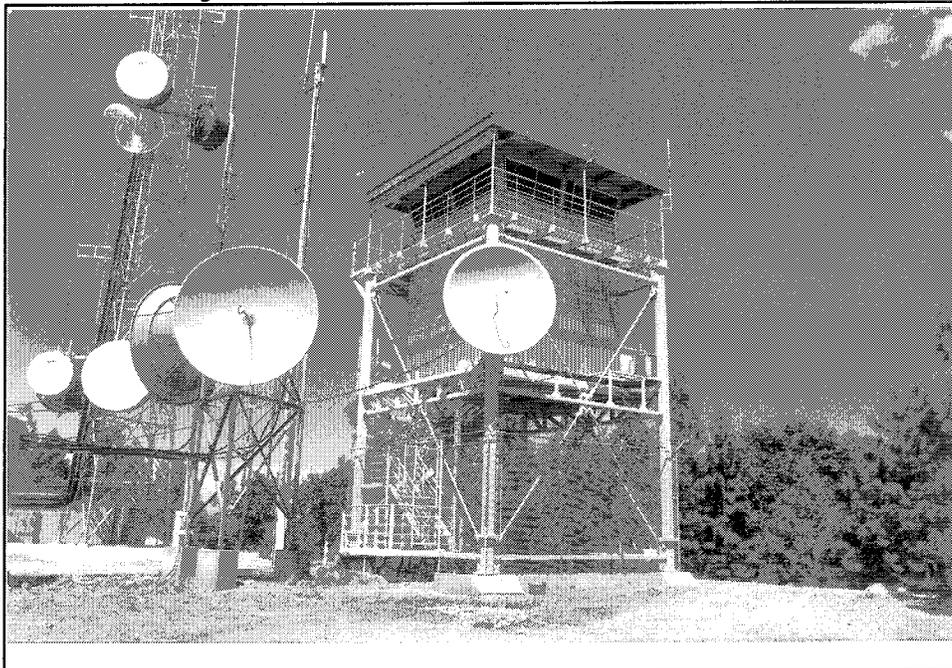
7. Briefly describe the present physical appearance of the property, including condition, boundaries, related features, surroundings, and (if appropriate) architectural style. This 21'x21'x29' (high) nonbattered, open steel (H-brace) tower has a concrete pier foundation and supports a 196 sq. ft. cab. A 196 sq. ft. room is located below the cab. A steel stairway extends up the inside of the tower to a large landing next to the second story room. From here the stairs ascend up the outside of the north tower face. The second story serves as a bathroom/bedroom. The room rests some 15' above the ground, upon steel stringers extending from the tower's cross bracing. The room and cab form an integral unit, being of wood frame construction with corrugated aluminum siding. The cab has vinyl tile flooring, wood paneling, open beam ceiling and built-in cabinets. The slightly gabled roof is covered in corrugated aluminum. All windows are aluminum sliders, with the cab's glass set at an angle. The 36" wide catwalk and 42" high handrail are of steel construction.

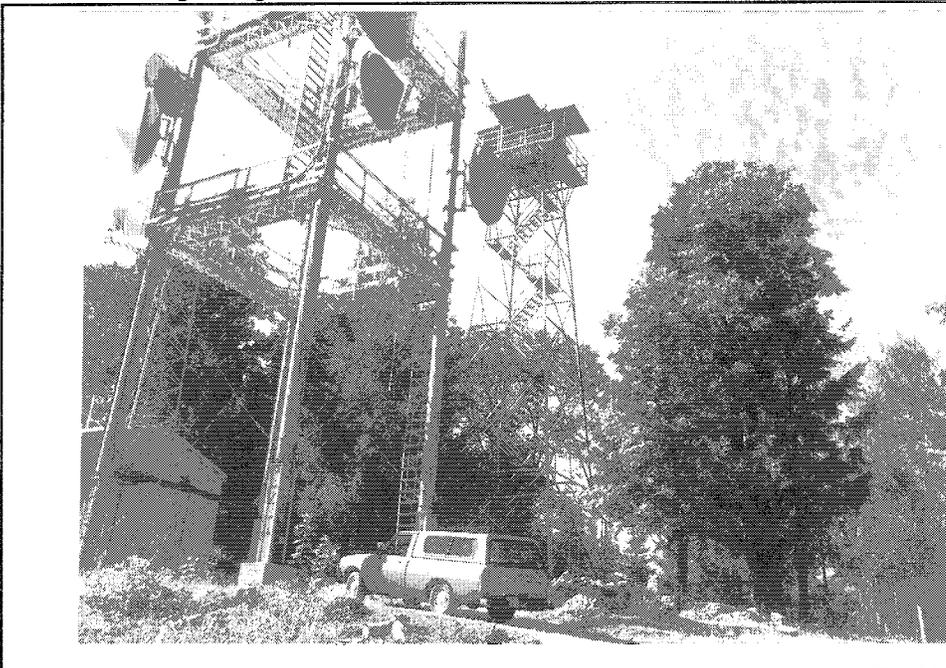
7. Briefly describe the present physical appearance of the property, including condition, boundaries, related features, surroundings, and (if appropriate) architectural style. This station consists of a 16'x16' (base) 60' (high) battered, open steel (X-brace) tower, a 437 sq. ft. wood frame residence, and a 240 sq. ft. wood frame garage. The tower has a concrete pier foundation and supports a 49 sq. ft. metal cab. A steel stairway extends up inside the tower to a wooden trap door in the cab floor. Cab windows are 1/1 aluminum sliders. A metal door (with glass upper panel) opens onto the all steel, 36" wide catwalk (42" high rail). A pyramidal hip roof covers the cab. Both the garage and house are rectangular buildings with asbestos tile siding, corrugated aluminum sheeting over gable roof and open eaves. The house has a concrete perimeter foundation, metal frame, casement windows, wood doors and aluminum screen doors. The garage has a concrete slab foundation, wood door and a casement window on its west wall. An overhead, aluminum garage door is located on the south gable end.

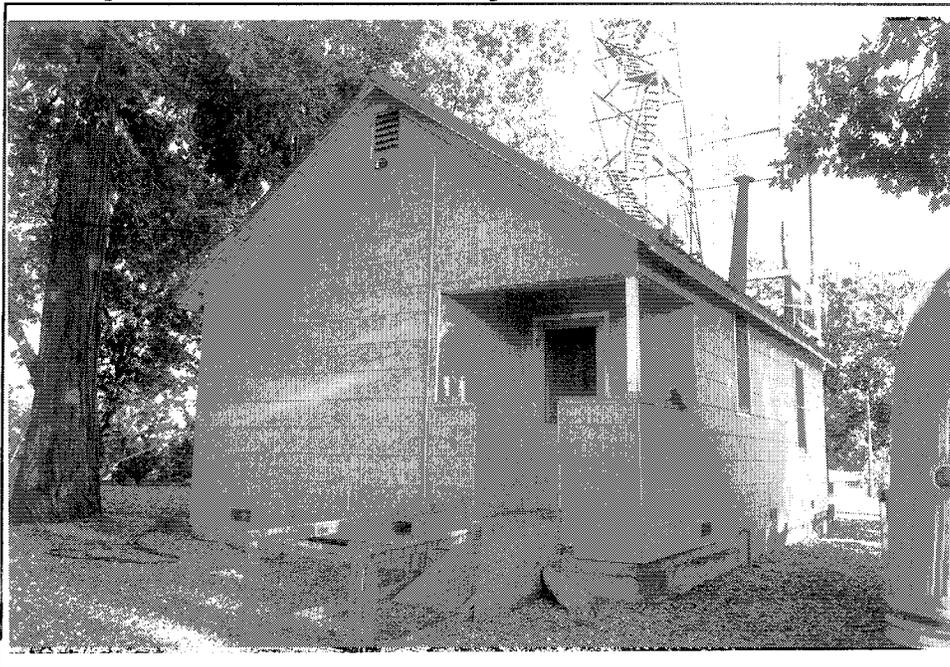
7. Briefly describe the present physical appearance of the property, including condition, boundaries, related features, surroundings, and (if appropriate) architectural style. This station consists of a 16'x16' (base) 60' (high) battered, open steel (X-brace) tower, a 540 sq. ft. wood frame residence, and a 320 sq. ft. wood frame garage. The tower has a concrete pier foundation and is topped with a 49 sq. ft. metal cab. A steel stairway (wood steps) extends up inside the tower to a trap door in the cab floor. Cab windows are 1/1 sliders. A metal door (with glass upper panel) opens onto the all metal, 36" wide catwalk (42" high rail). The cab has a pyramidal hip roof. The house has a concrete perimeter foundation, asbestos tile siding, and corrugated metal on a gable roof. Eaves feature a plain fascia. A 5'x12' (T&G flooring) front entry porch is recessed under the southeast corner of the house roof. A smaller, porch is recessed under the northwest roof corner. The garage has a concrete slab foundation, asbestos tile siding and corrugated metal covered gable roof.

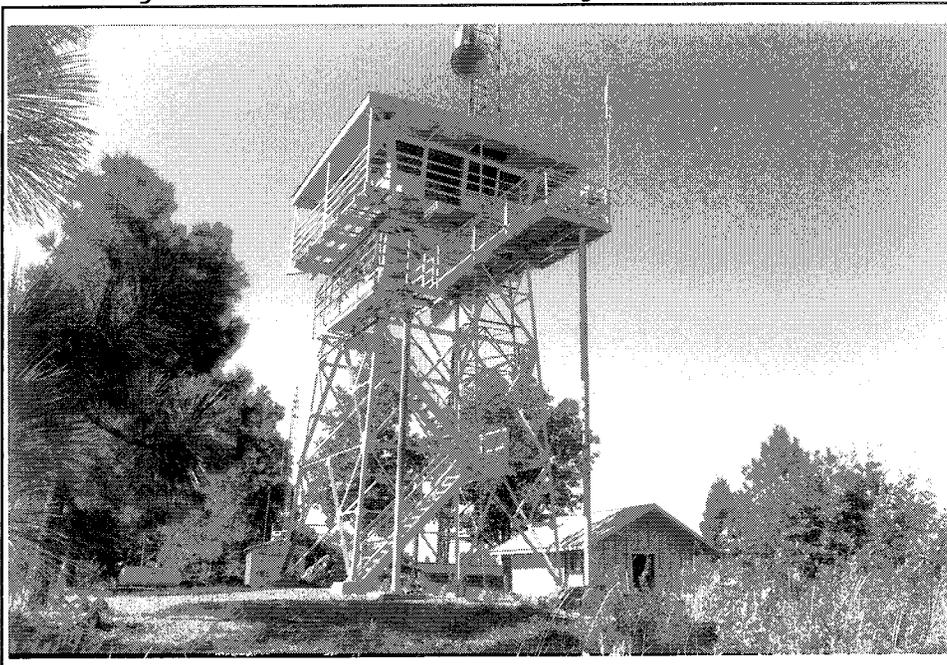
7. Briefly describe the present physical appearance of the property, including condition, boundaries, related features, surroundings, and (if appropriate) architectural style. The 18'x18' (base) 30' (tall) battered open steel (K-brace) tower has a concrete pier foundation and supports a 196 square foot, wood frame cab. A steel stairway extends up inside the tower to a landing located below the cab, from here it ascends up the north face of the tower to the catwalk. The square cab has vinyl tile flooring, open beam ceiling and built-in cabinets. The cab's nearly flat gable roof is covered with corrugated metal. Eaves feature a plain fascia. Cab windows are aluminum sliders, set on an angle. The cab's door (which has a glass upper panel) is off-set on the north side. The 35" wide catwalk and 41" high handrail are of steel construction. A 196 square foot utility building is located on the west side of the lookout. It houses water system, radio equipment and bathroom facilities. It has a concrete slab foundation, plywood and batten siding, and a corrugated aluminum covered gable roof.

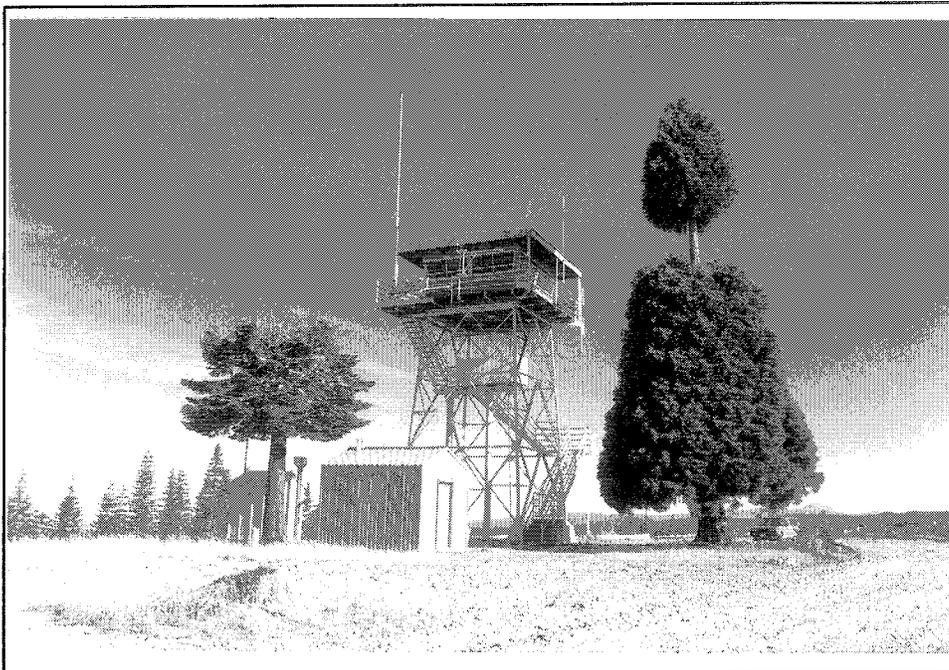
7. Briefly describe the present physical appearance of the property, including condition, boundaries, related features, surroundings, and (if appropriate) architectural style. This 18'x18' (base) 33' (tall) battered, open steel (K-brace) tower has a 3' high, concrete pier foundation and supports a 196 sq. ft., wood frame cab. A stairway wraps around the east, north and west side of the tower extending up to the steel catwalk and guard rail (34"x41"). The cab is of a later vintage than the tower. It features vinyl tile flooring, wood paneling, open beam ceiling and built-in cabinets. The cab's nearly flat gable roof is covered with corrugated aluminum. Eaves feature a plain fascia. Cab windows are tilted, aluminum frame 1/1 sliders. The cab's door is off-set on the west wall, aluminum covers the exterior walls. On the south side of the tower is a 120 sq. ft., gable roofed utility shed. It contains bathroom facilities. The rectangular, wood frame building has a concrete slab foundation, and corrugated aluminum siding and roofing.

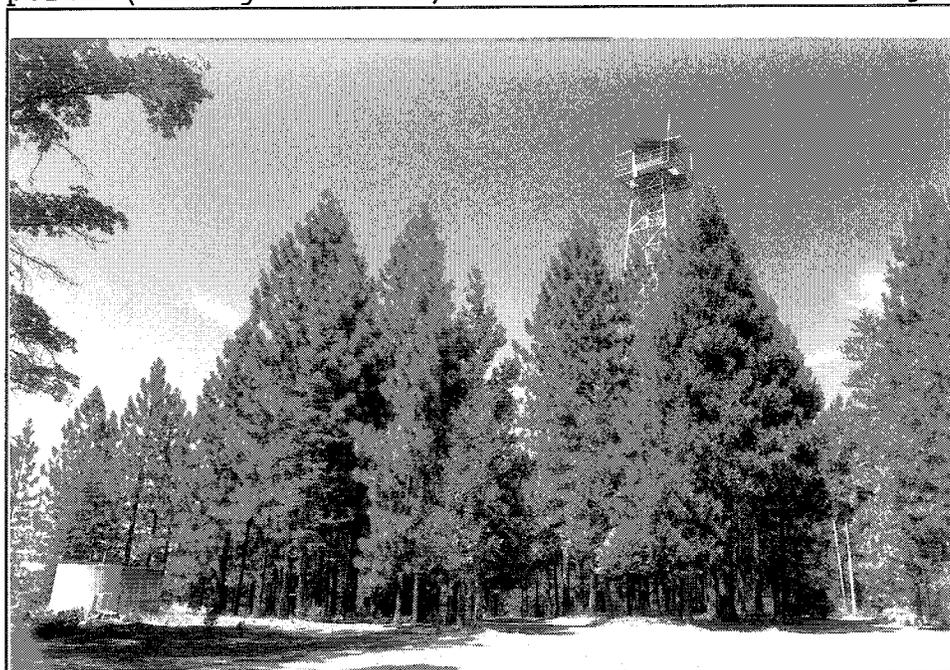
7. Briefly describe the present physical appearance of the property, including condition, boundaries, related features, surroundings, and (if appropriate) architectural style. This station consists of a 21'x21' (base) 93' (high) battered, open steel (X-brace) tower and a 475 sq. ft., wood frame residence. The tower has a concrete pier foundation and is topped with a 49 sq. ft. metal cab. A steel stairway extends up inside the tower to a wooden trap door in the cab floor (124 steps from the base to the cab). Cab windows are aluminum framed, 1/1 sliders. A metal door, with upper glass panel, opens onto the 36" wide catwalk (42" high rail). The cab has a pyramidal hip roof. The residence is divided into a kitchen and bedroom/bath. This building has a concrete perimeter foundation, asbestos tile siding, and a corrugated metal gable roof. Eaves feature a plain fascia. The windows in the bedroom area are 4/4 fixed pane and casements. Original windows have been replaced with 1/1 aluminum sliders, in the kitchen area. A 5'x14' concrete floor, front entry porch (with gable roof) is located on the east gable end of the house.

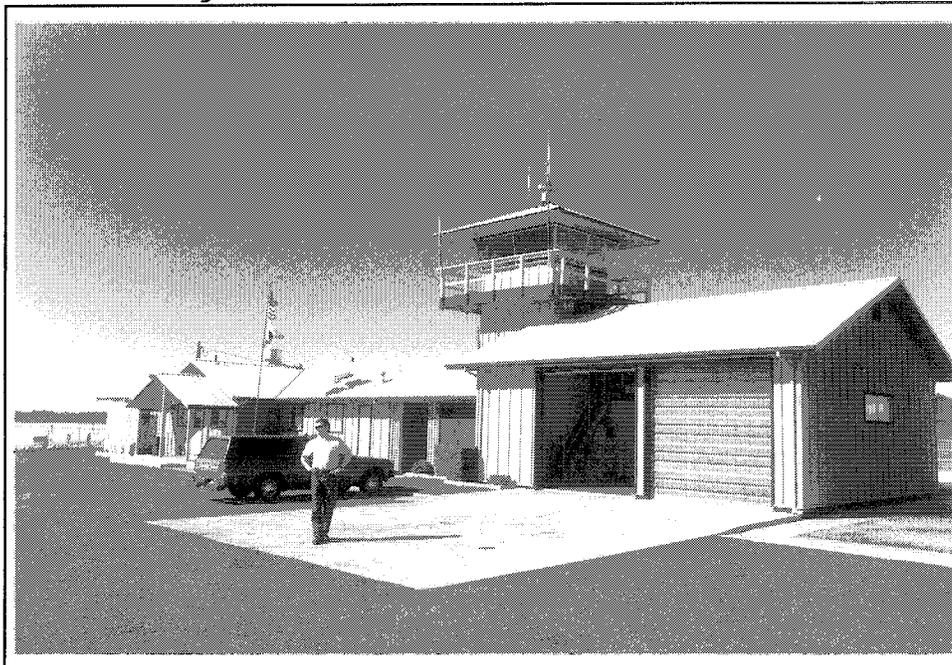
7. Briefly describe the present physical appearance of the property, including condition, boundaries, related features, surroundings, and (if appropriate) architectural style. This large building complex (over 3,500 square feet) features a two truck (fire engine) bay at the south end and a "U" shaped barracks/kitchen and mess hall addition on the north end of the structure. Connecting the two ends is a smaller rectangular section, providing space for offices, reception, bathroom and lounge areas. Above the office/reception rooms is a small storage room, upon which a 90 sq. ft. cupola sits. This station has a concrete slab foundation, plywood and batten siding and aluminum ribbed roofing over gable roofs. The windows are aluminum frame sliders and the doors are wood with aluminum screen doors. The storage room below the cupola is accessed via a wooden stairway inside the truck bay. An external, steel stairway leads up from the back side of the building to the lookout cupola. The cupola has a pyramidal hip roof. The 38" wide catwalk and 42" high handrail are of wood construction.

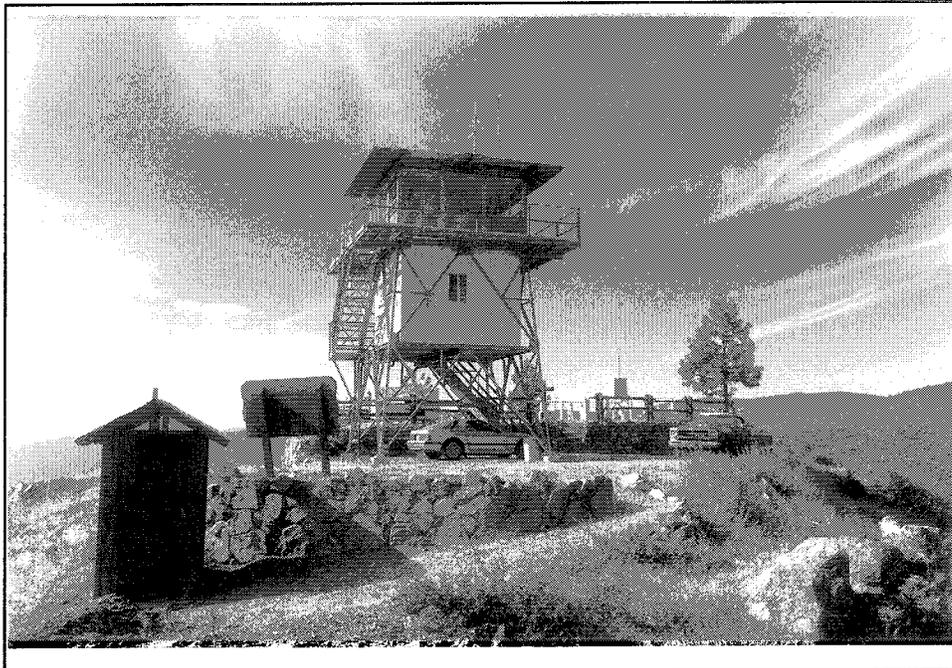
7. Briefly describe the present physical appearance of the property, including condition, boundaries, related features, surroundings, and (if appropriate) architectural style. This 17'x17' (base) x21' (tall) battered, open steel (K-brace) tower has a concrete pier foundation and supports a 169 sq. ft., metal cab. A 144 sq. ft., wood frame room is located below the cab. A steel stairway extends up the south side of the tower to a landing next to the second story (kitchen/shower) room. Thence, the stairs ascend up the east side to trap doors in the catwalk. Supported by steel stringers extending from the tower's cross bracing, the lower room has particle board flooring, wood paneling, fiberboard ceiling, and corrugated aluminum siding. 1/1 sliding windows are set in each wall. The cab has large 1/1, fixed pane windows on all sides. A small awning window over fixed pane over another awning window is located on three sides. A metal door, which features a glass upper panel, is on the west wall. The flat roof is covered in corrugated metal. The 32" wide catwalk and 42" high handrail are of steel construction.

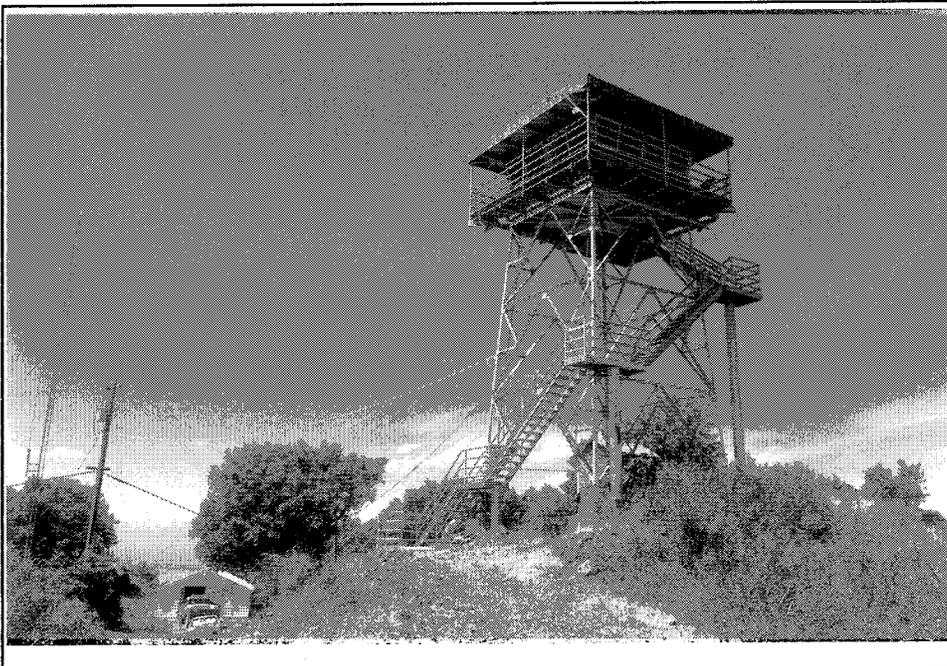
7. Briefly describe the present physical appearance of the property, including condition, boundaries, related features, surroundings, and (if appropriate) architectural style. Twenty-four concrete and stone steps lead from the parking area up to the lookout tower base. The 18'x18' (base) 31' (tall) battered, open steel (K-brace) tower has a concrete pier foundation and supports a 196 sq. ft., wood frame cab. A steel stairway wraps around the south, west and north side of the tower up to the catwalk. The square cab has vinyl tile flooring, wood paneling, open beam ceiling and built-in cabinets. The cab's nearly flat gable roof is covered with corrugated metal. Eaves feature a plain fascia. Cab windows are tilted, aluminum sliders. The cab's door is off-set on the north side; cab siding is corrugated aluminum. The 35" wide catwalk and 42" high handrail are of steel construction. A 462 sq. ft. wood frame garage is located by the parking area. The structure has a concrete slab foundation, vinyl lap siding, and aluminum covered gable roof.

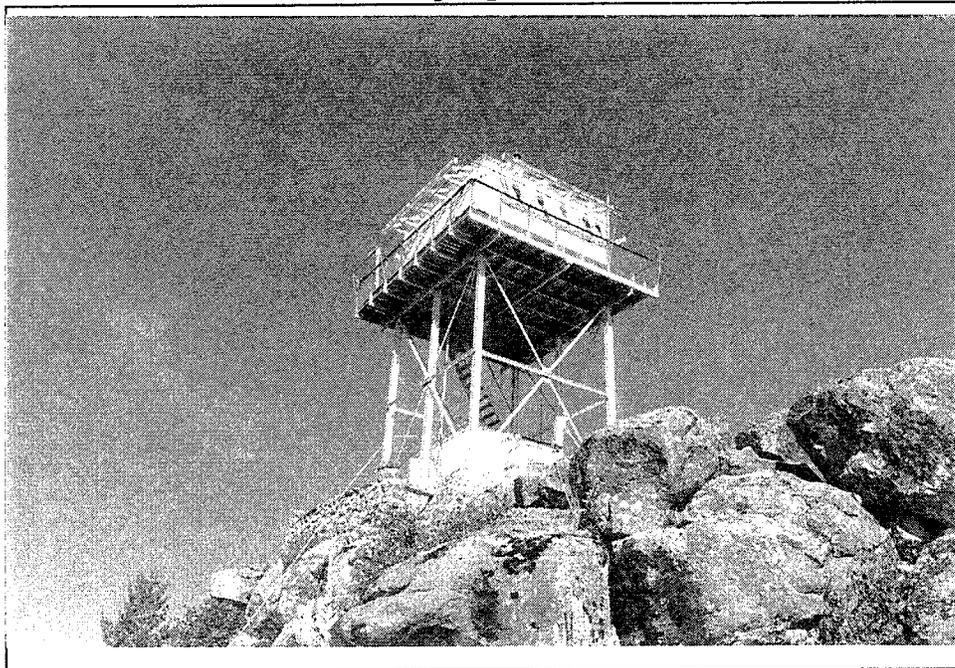
7. Briefly describe the present physical appearance of the property, including condition, boundaries, related features, surroundings, and (if appropriate) architectural style. The 14'x14'x20' (tall) nonbattered, open steel (H-brace) tower has a mortar and stone pier foundation and supports a 196 square foot, wood frame cab. The cab has "v" groove rustic siding and paneling, T&G ceiling, linoleum flooring and built-in cabinets. The pyramidal hip roof is covered by wood shingles. Five, single pane windows are located on three walls, the center windows are hopper types. The north wall has four windows and a centered wood door (which has a glass upper panel). The wood catwalk and steel guardrail are 34" wide by 31" high (with an 11" iron pipe extension on the rails). The garage has a concrete slab foundation, "v" groove siding, and wood shingles on a gable roof. A five panel, wood door is centered on the east wall, flanked by 2/2, fixed windows. Two windows are also on the west wall, and two are side by side on the north wall. Two doors on the south wall swing open for vehicle access.

13. Threats: Station is
closed, vandalized.

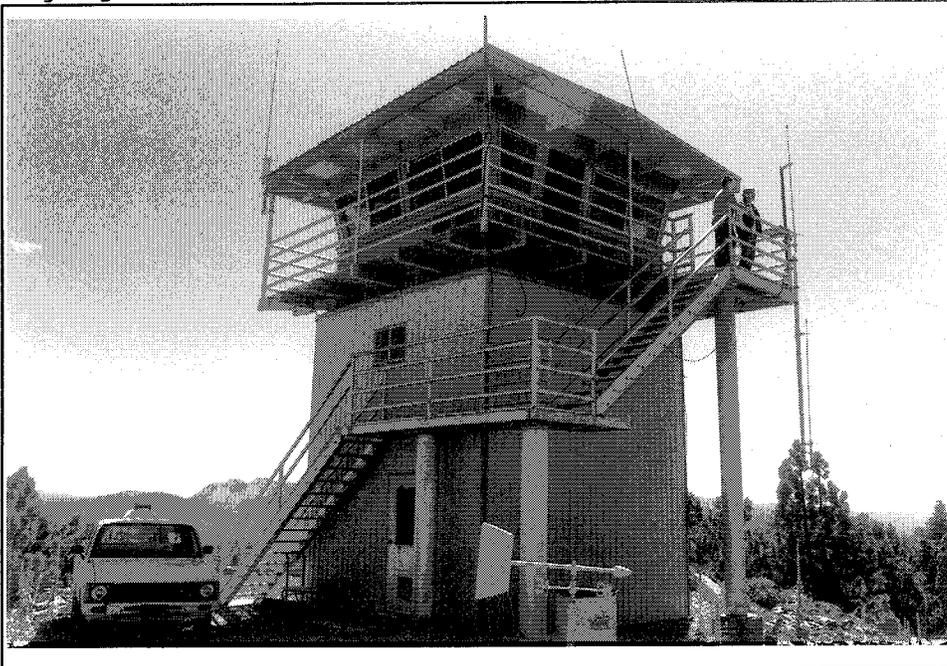
7. Briefly describe the present physical appearance of the property, including condition, boundaries, related features, surroundings, and (if appropriate) architectural style. The lookout is a 16'x16'x18' (tall) nonbattered, enclosed timber tower with a concrete perimeter foundation and topped with a replacement wood frame cab. The ground floor contains bathroom facilities and has a poured concrete floor. The interior is unfinished, tower framing is exposed. An internal, wood stairway leads to the second floor, which houses a 500 gallon water storage tank, pumping system and repeaters. A steel stairway leads up from the ground to the catwalk, wrapping around the north and west side of the tower. The 196 sq. ft. cab has vinyl tile flooring, open beam ceiling and built-in cabinets. The cab's nearly flat, gable roof is covered with corrugated aluminum. Eaves feature aluminum covered fascia boards. The cab windows are 1/1 aluminum sliders, set on an angle. The cab door is off-set on the west side. The 36" wide catwalk and 42" high guardrail are of steel construction.
