The 1991

Survey

of the

California Department of Forestry and Fire Protection's

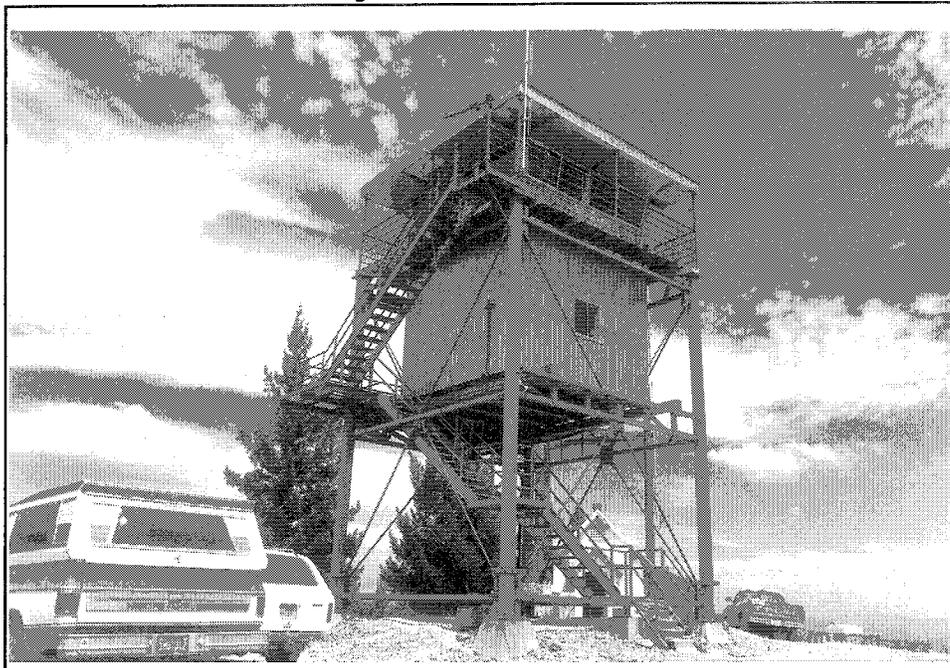
7. Briefly describe the present physical appearance of the property, including condition, boundaries, related features, surroundings, and (if appropriate) architectural style. This 21'x21'x29' (high) nonbattered, open steel (H-brace) tower has a concrete pier foundation and supports a 196 sq. ft. cab. A 196 sq. ft. utility room is located below the cab. A steel stairway extends up the inside of the tower to a large landing next to the utility room. From here the stairs ascend up the outside of the west tower face. Supported by steel I-beam stringers extending from the tower's cross bracing, the second story utility room contains bathroom facilities. This room and the cab form an integral unit, being of wood frame construction with corrugated aluminum siding, vinyl tile flooring, open beam ceilings, and built-in cabinets. Interior paneling is sheet rock below and wood in the cab, windows are 1/1, aluminum frame sliders. The cab's glass is set on an angle. The nearly flat gable roof is covered in corrugated aluminum. The 36" wide catwalk and 42" high handrail are of steel construction.

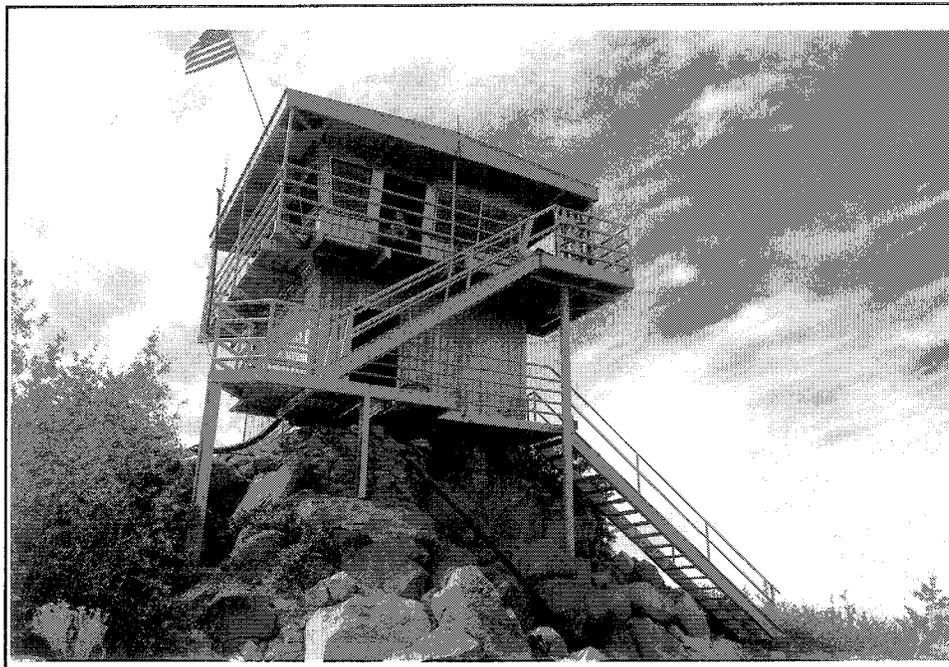
7. Briefly describe the present physical appearance of the property, including condition, boundaries, related features, surroundings, and (if appropriate) architectural style. This 14'x14'x9' (tall) nonbattered, enclosed steel (H-brace) tower has a concrete foundation and supports a 196 sq. ft. wood frame cab. The lookout is located upon a rocky peak. A steel staircase (18 steps) leads up to the tower base. The first floor serves as a utility room, housing bathroom facilities and a 1,000 gallon water storage tank. The utility room has corrugated aluminum siding and an open beam ceiling. From the large steel landing outside this floor, a steel stairway leads up the north side of the tower to the catwalk. The square cab features corrugated aluminum siding and roofing (over a nearly flat gable roof), plain fascia and aluminum frame, sliding windows. The door is off-set on the north wall of the cab. The interior has vinyl tile flooring, wood paneling and an open beam ceiling. The steel catwalk and handrail are 36"x42" (respectively).

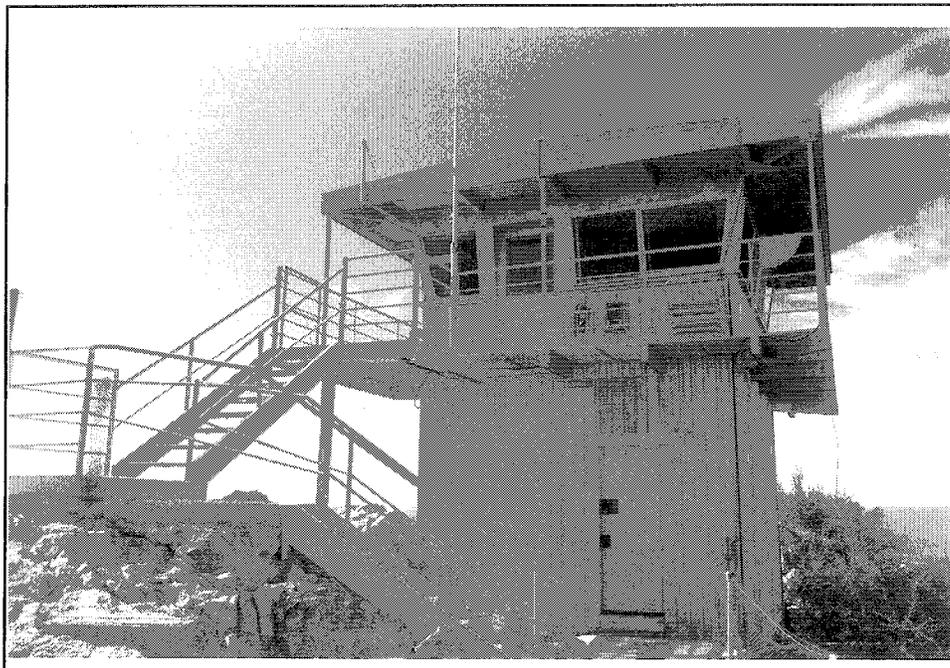
7. Briefly describe the present physical appearance of the property, including condition, boundaries, related features, surroundings, and (if appropriate) architectural style. This 14'5"x14'5"x11'7" (high) nonbattered, enclosed steel (H-brace) tower has a concrete pier foundation and supports a 196 sq. ft. wood frame cab. The first story houses a 500 gallon water storage tank, bathroom facilities, refrigerator and hot water tank. It has a wood floor, one 1/1 sliding window, a wood door (covered in metal sheeting) and aluminum siding. A steel stairway ascends up the northeast side of the tower to the catwalk. The cab has vinyl tile flooring, wood paneling, open beam ceiling and built-in cabinets. The cab's nearly flat gable roof is covered with corrugated aluminum. Eaves feature a plain fascia. Cab windows are tilted, aluminum sliders. The cab's door is off-set on the northeast side; cab siding is corrugated aluminum. The 36" wide catwalk and 42" high handrail are of steel construction, vertical framing extends up to the eaves.

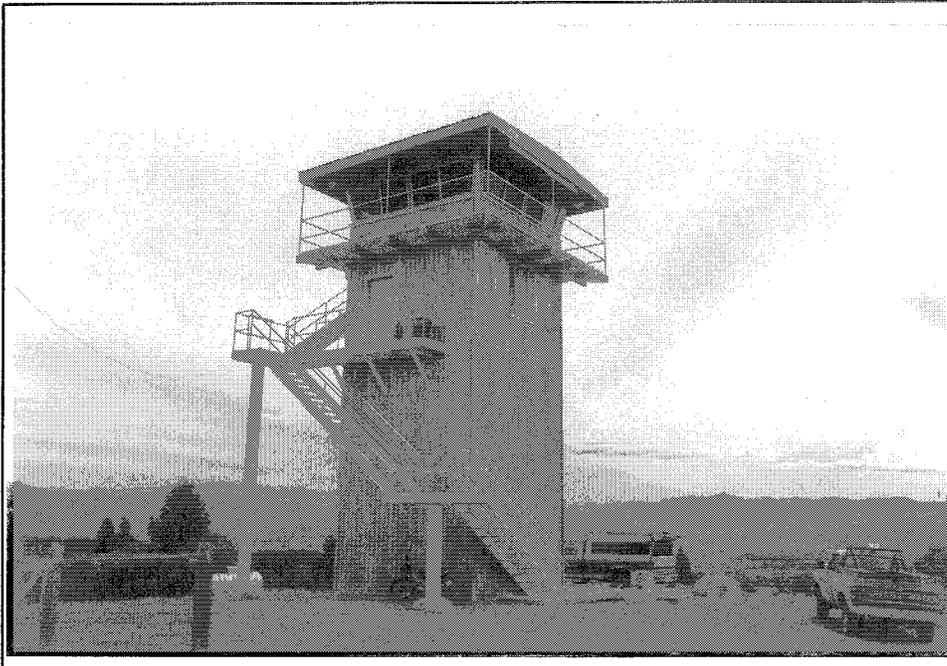
7. Briefly describe the present physical appearance of the property, including condition, boundaries, related features, surroundings, and (if appropriate) architectural style. This 14x'14' (base) x30' (high) nonbattered, enclosed steel (H-brace) tower has a concrete slab foundation, corrugated metal siding and supports a 196 square foot, wood frame cab. A door centered on the south wall provides access to the ground floor. A self supporting, steel stairway wraps around three sides of the tower. A second floor landing (some 20' above the ground) is located on the north side of the upper story room. This room has a single entry door. A small 1/1 sliding window is on the east wall and a larger 1/1 slider is on the west. The cab has vinyl flooring, wood paneling, open beam ceiling and built-in cabinets. The cab's nearly flat gable roof is covered with corrugated aluminum; eaves feature a plain fascia. Cab windows are tilted, aluminum sliders. The cab's door is off-set on the east side; cab siding is corrugated aluminum. The 36" wide catwalk and 42" high handrail are of steel construction.

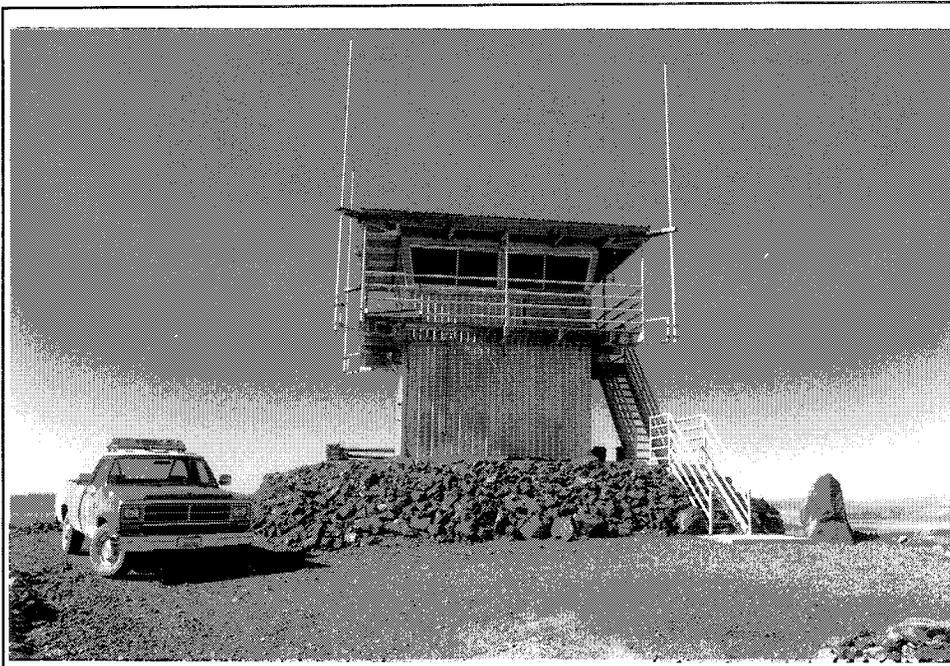
14. Construction date(s): 1972 F Original location: Same Date moved:
15. Alterations & date:
16. Architect: CDF (Plan Number 655-A-1A) Builder:
17. Historic attributes (with number from list):

This lookout replaced a structure that had been erected in 1942. The old tower foundation, with rock retaining walls around the building pad, is located on the north side of the existing lookout. The subject tower is based on Plan Number 655-A-1A, which was revised in early 1972 to incorporate 12" diameter columns for corner posts. These pipes make for a strong and heavy tower frame. Sacramento engineers wanted the design to prove itself; therefore, there was a two year delay before any more of these tower types were constructed. Four additional towers have since been erected. Enough pipes are still on hand at the Intermountain Conservation Camp to fabricate at least one more tower. A boulder, on the east side of the lookout, has a bronze plaque attached which reads: "Fredonyer Lookout, In Memory of Richard K. Smith, State Forest Ranger, For Dedicated Service, 1946 to 1973." (The practice of renaming lookout stations had long since ceased.)

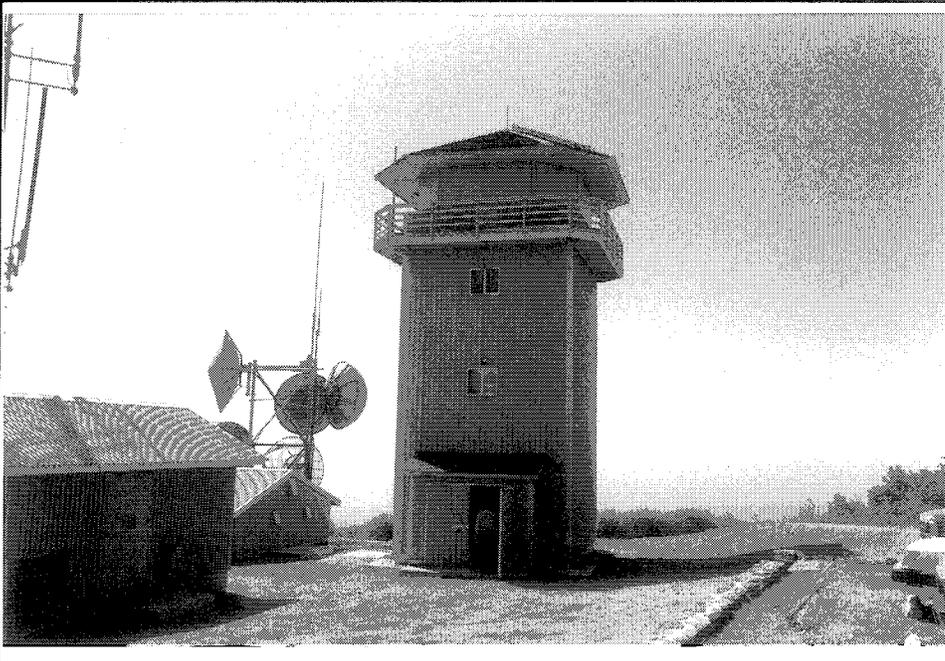
14. Construction date(s): 1948 F Original location: Same Date moved:
15. Alterations & date:
16. Architect: CDF (Plan No. 809R) Builder: CDF
17. Historic attributes (with number from list): 09

This is a splendid example of CDF's original 809R lookout design, The chief alterations are: aluminum siding added, wood fire escape ladder removed and front entry remodeled. Also, single, 1/1 aluminum frame sliding windows (centered on the east and south walls of both the second and third story) have replaced the original tower windows. The cab features original built-in cabinets and attractive, "v" groove rustic interior paneling. Even the firefinder stand is composed of the "v" groove boards. Third floor bathroom fixtures appear to be contemporaneous. All interior doors look original. There is a 200 sq. ft., well house, generator and water storage building on the east side of the tower. It's sided and roofed in corrugated metal. It has a gable roof.

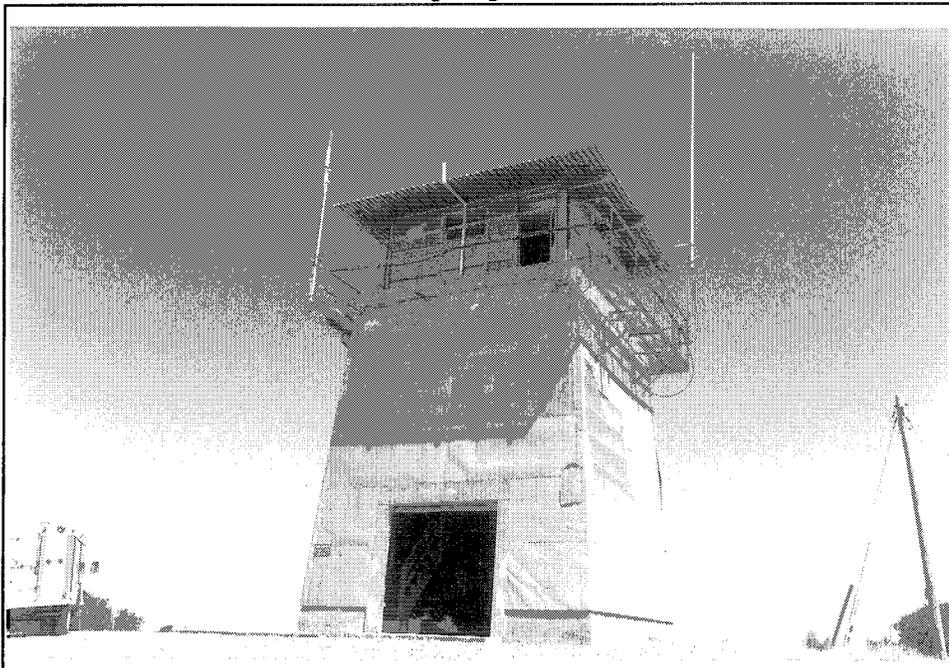
7. Briefly describe the present physical appearance of the property, including condition, boundaries, related features, surroundings, and (if appropriate) architectural style. The 18'x18' (base) 20' (high) battered, enclosed timber tower has a concrete perimeter foundation (cement floor), aluminum siding and is topped with an all metal cab. A repeater and refrigerator are on the ground floor. A steel I-beam has been installed under the second floor joists. An internal, wood staircase leads up to a second floor bedroom/bath area. This room has linoleum flooring, drywall paneling, a dropped ceiling and two small aluminum frame sliders. A second floor door opens onto a small, outside wood landing and stairway. Wood stairs ascend up the north tower face to a steel, trap door in the catwalk. The cab has linoleum flooring, fixed pane (& casement) windows, and a metal, flat roof. A metal door (with glass upper panel) is on the west side. A steel, folding fire escape ladder is located on the east side of the cab. The 45" wide catwalk and the 42" high guardrail are of steel construction.

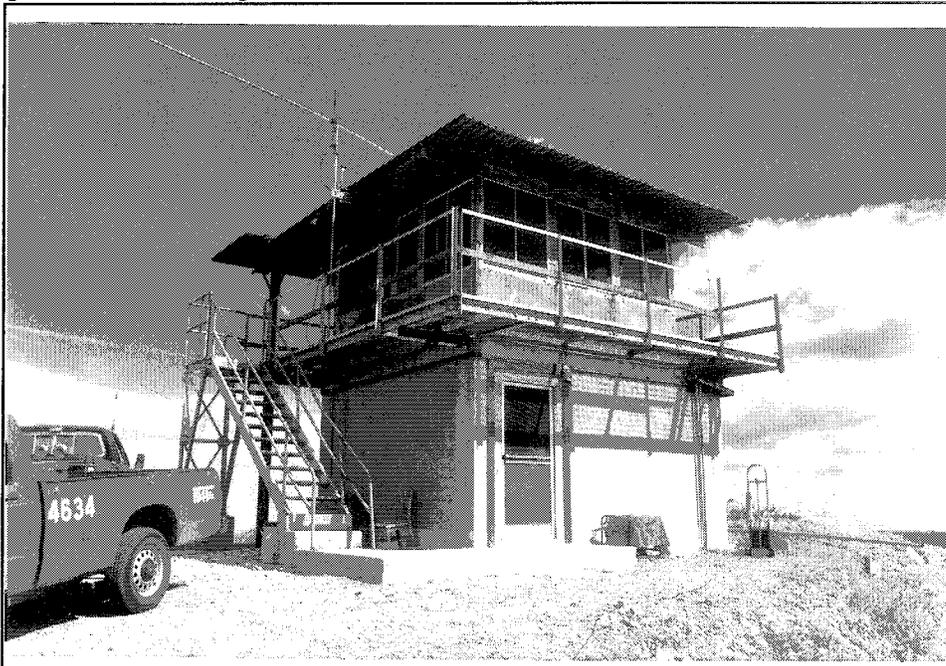
14. Construction date(s): 1976 F Original location: Same Date moved:
15. Alterations & date:
16. Architect: Tower = CDF; Cab = Forest Service (CL-30) Builder: CDF
17. Historic attributes (with number from list): 09

The concrete tower is topped with a Forest Service cab design (Plan No. CL-30). The Forest Service has been using the CL-30, Nation-wide, as a standard replacement cab since the 1950s. The Smith Mountain cab was originally located upon a concrete base at Black Mountain. CDF acquired the cab from the Los Padres National Forest in 1976. The lookout has undergone little change since its installation upon Smith Mountain. This is CDF's only concrete block building with CL-30. CDF has a total of three CL-30s in its system. The support structure for a windmill is located against the southeast corner of the tower (generator and blades are gone). The storage building's construction date is unknown. Smith Mountain's first lookout was erected circa 1930; a BC-301 cab replaced it in 1944.

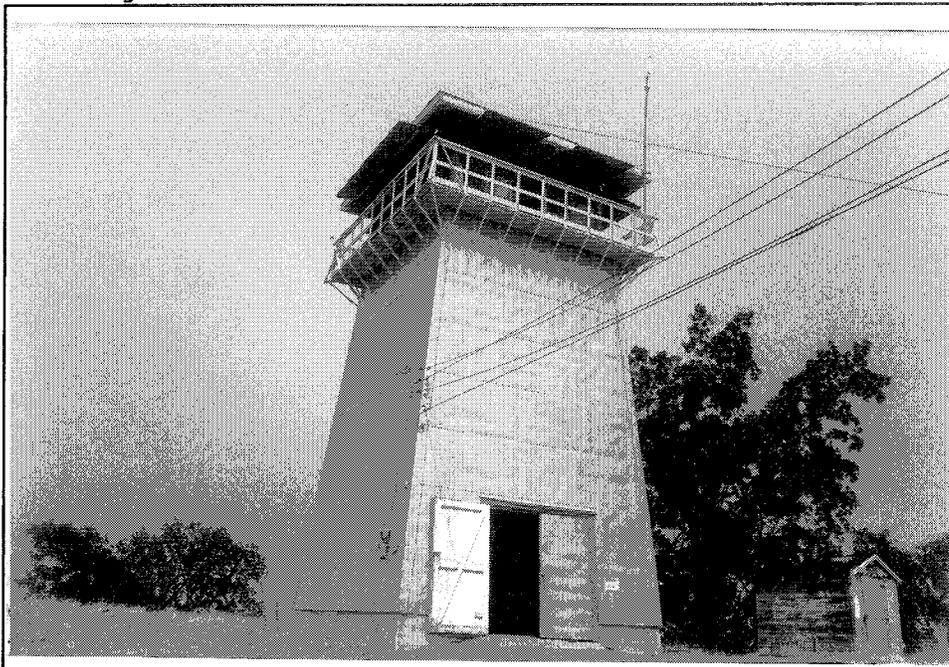
7. Briefly describe the present physical appearance of the property, including condition, boundaries, related features, surroundings, and (if appropriate) architectural style. The 20'x20' (base) 30' (high) battered, enclosed timber tower has a concrete perimeter foundation (cement floor), aluminum siding and supports a 196 sq. ft., wood frame cab. Two "garage" doors, centered on the east side, swing open to provide ground access. The interior is unfinished (tower framing exposed). Two flights of stairs ascend to an upper story utility room which has T&G flooring and contains a 500 gallon water storage tank and pump system. A wood door opens to the outside landing, thence a metal staircase ascends up the north tower face to the catwalk trap door. The cab has "v" groove siding (aluminum sheeting below the windows) and paneling, linoleum flooring, T&G ceiling, single pane, fixed windows (one hopper on three sides) and a plain fascia. Asphalt composition shingles cover the pyramidal hip roof. Catwalk and handrail are 27" wide by 42" high.

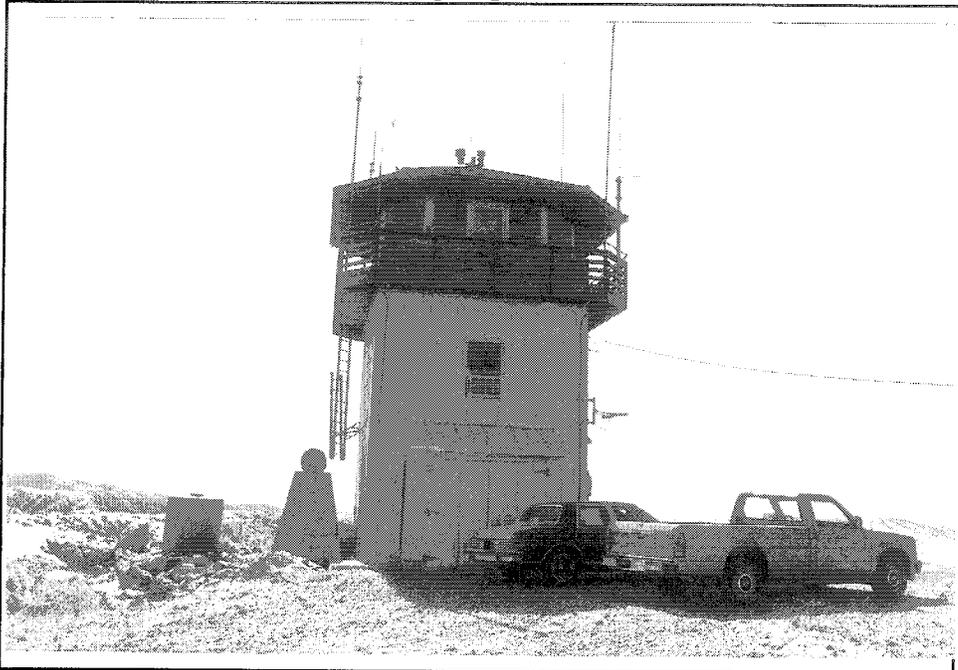
7. Briefly describe the present physical appearance of the property, including condition, boundaries, related features, surroundings, and (if appropriate) architectural style. The 16'x16'x20' (tall) enclosed steel (K-brace) tower has a concrete slab foundation, aluminum siding (over wood framing) and supports a 247 sq. ft., wood frame cab (which has octagonal roof and window patterning). Centered on the east tower wall is a 3'x11'x7' (high) shed roof, entry annex. The two "garage" doors are wood with aluminum veneers. The ground floor interior walls are unfinished (framing exposed). Internal, wood stairs lead to the second floor bedroom area. The room has plywood paneling on walls and ceiling. "V" groove paneling is on one bedroom wall, in the stairwell to the cab and in the cab (cab siding, too). Cab ceiling and flooring is T&G. Windows are stationary plate glass on the cardinals and hoppers on the diagonals. Eaves are boxed, roofing is wood shingles. A wood door with glass panel is centered on the east. The 33" wide catwalk and the 36" high guardrail are of wood construction.

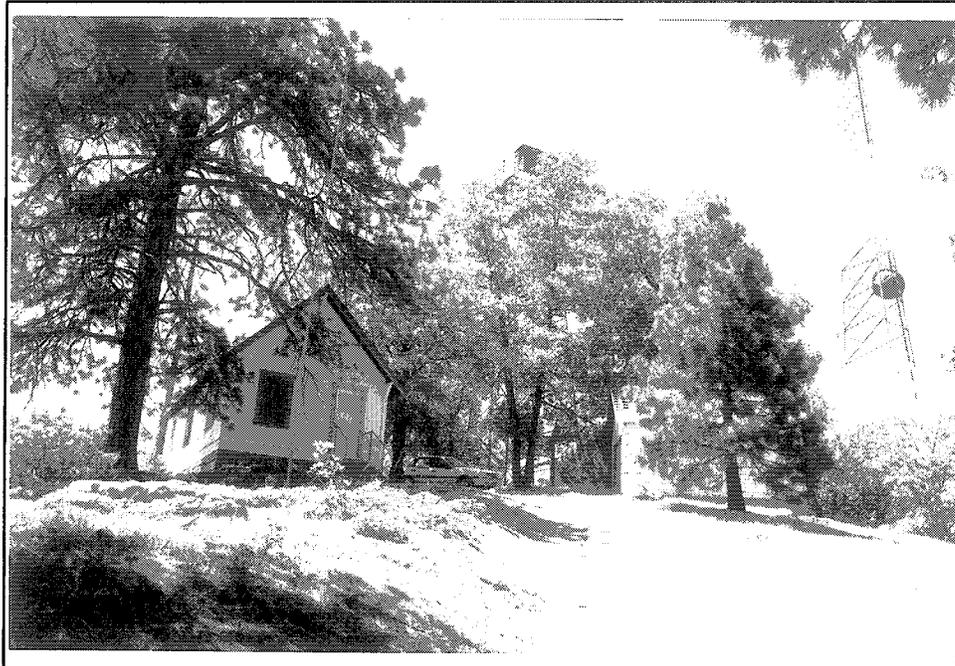
7. Briefly describe the present physical appearance of the property, including condition, boundaries, related features, surroundings, and (if appropriate) architectural style. This station consists of a 16'x16' (base) 60' (high) nonbattered, open steel (X-brace) tower, a 384 sq. ft., wood frame residence and a 240 sq. ft. wood frame garage. The tower has a concrete pier foundation and is topped with a 49 sq. ft. metal cab. A steel stairway extends up inside the tower to the cab's wooden trap door. Cab windows are 1/1 sliders. A metal door (with glass upper panel) opens onto the catwalk. The 36" wide catwalk and 42" high guardrail are of steel construction. The cab has a pyramidal hip roof. The house and garage both have "v" groove siding, and wood shingles on gable roofs. The garage has a concrete slab foundation and the house has a pier and post foundation. House windows are 2/2, double hung. The wood front door has a glass upper panel and is located on the east, gable end of the house. A 48 sq. ft., enclosed, rear porch with gable roof is on the west end, it has 6/6 casement windows. Eaves are open.

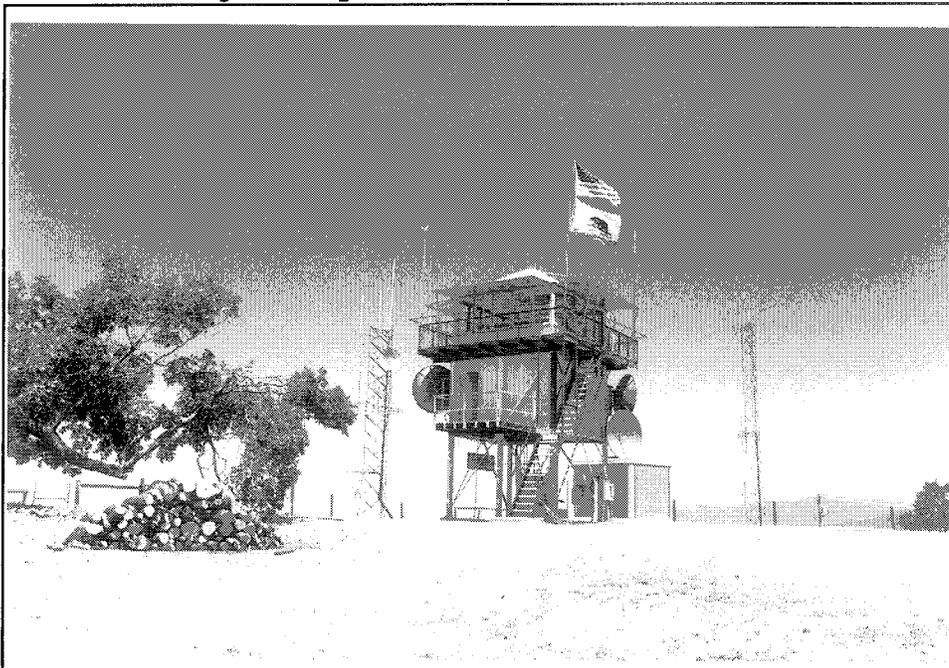
14. Construction date(s): 1943 F Original location: Same Date moved:
15. Alterations & date:
16. Architect: Forest Service Builder: U.S. Army
17. Historic attributes (with number from list): 09, 34

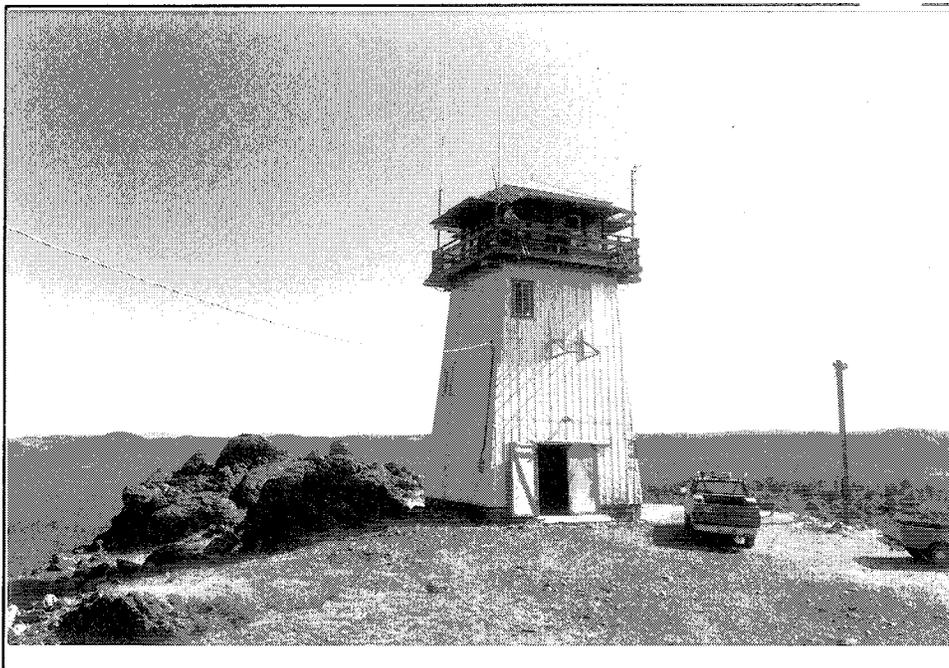
14. Construction date(s): 1936 F Original location: Same Date moved:
15. Alterations & date:
16. Architect: Forest Service (L-601 & BC-301) Builder: CCC
17. Historic attributes (with number from list): 09, 35

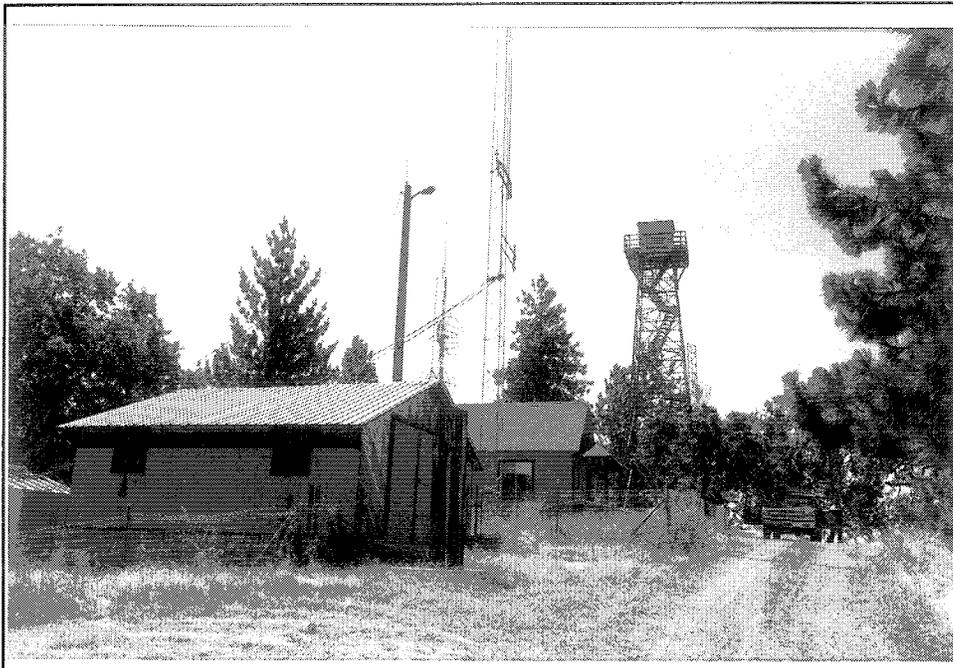
7. Briefly describe the present physical appearance of the property, including condition, boundaries, related features, surroundings, and (if appropriate) architectural style. This station consists of a 16'x16' (base) 60' (high) battered, open steel (X-brace) tower, a 480 sq. ft., wood frame residence and a 462 sq. ft. wood frame garage. The tower has a concrete pier foundation and is topped with a 49 sq. ft. metal cab. A steel stairway extends up inside the tower to the cab's trap door. Cab windows are 1/1 sliders. A 1 pane/1 panel door opens onto the steel catwalk and rail (36" wide by 42" high). The cab has a pyramidal hip roof. The rectangular house has a concrete perimeter foundation, "v" groove rustic siding, aluminum framed, 1/1 sliding windows and asbestos cement tiles on a gable roof (with plain soffit). A hip roof covered, concrete porch is across the west gable end (front door is here). The square garage has a concrete slab foundation, "v" groove siding and aluminum covered gable roof.

8. Planning Agency:
County Planning Dept.
9. Owner & Address:
Cal. Dept. of Forestry
& Fire Protection
1416 Ninth St.,
Sacramento, California
10. Ownership type: State
11. Present Use: Public
12. Zoning: NA
13. Threats: Station is
closed, vandalism.

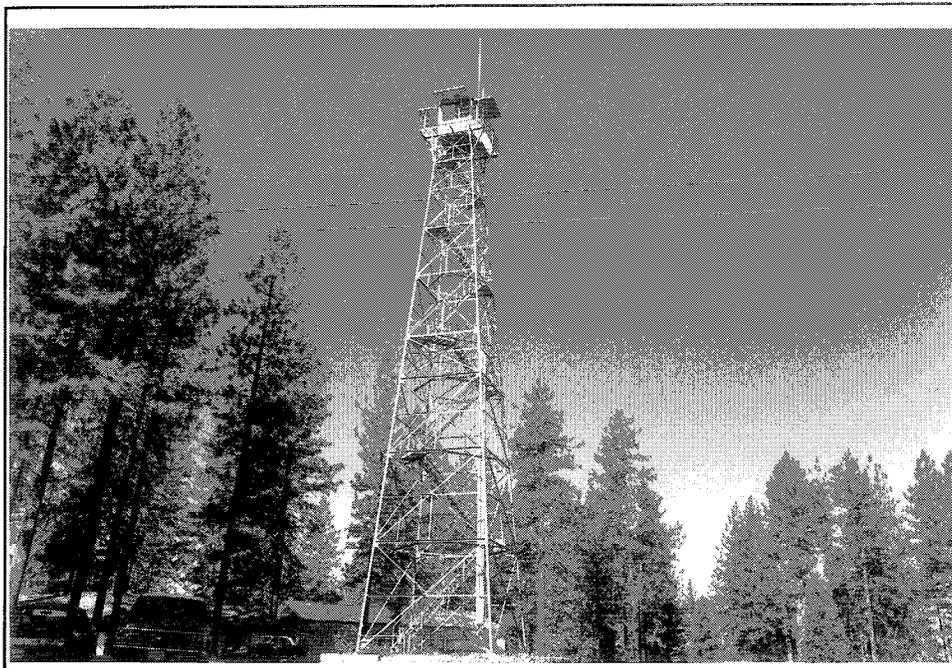
7. Briefly describe the present physical appearance of the property, including condition, boundaries, related features, surroundings, and (if appropriate) architectural style. The battered, open steel (X-brace) tower measures 22'x22' at the base and stands 100' tall. It has a concrete pier foundation and supports a 49 sq. ft. metal observation cab. A steel stairway (131 wood steps) extends up inside the tower to the cab's (wooden) trap door. Cab windows are 1/1 sliders. A 1 pane/1 panel, metal door opens onto the 36" wide steel catwalk (guardrail is 42" high). The cab has a metal, pyramidal hip roof. A low, stone retaining wall encircles the base of the tower. Inside of this is a lawn, bordered by a row of flowering plants. Cement walks lead to the foot of the tower's staircase. The lookout is surrounded by a large asphalt parking area, around the perimeter of which are located Amador-El Dorado Ranger Unit Headquarters and Mount Danaher Forest Fire Station facilities.
